# Site Photographs

Proposed Rehabilitation of  
Watercourses on Farm 15/37  
and Farm RE/37, Grootplaat,  
Aurora

APPENDIX C

Taken on 4 April 2026

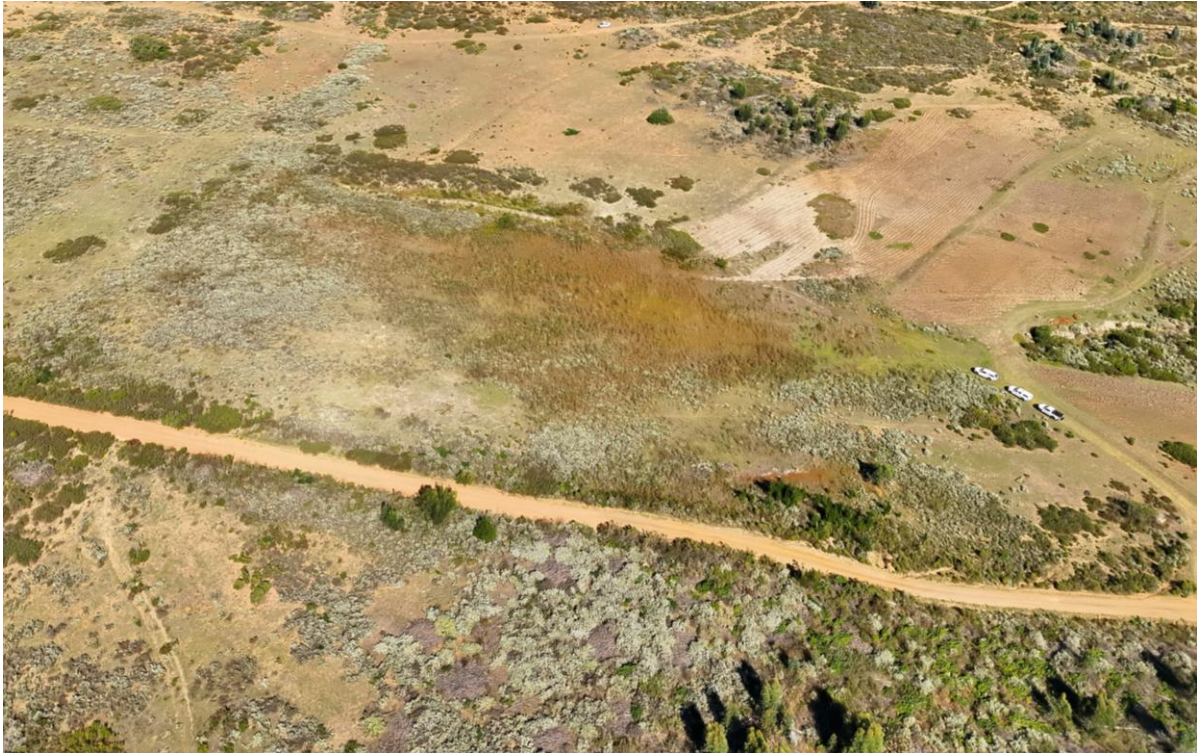
**Photograph 1**  
**Wetland Reach A (seep wetland) viewed from the north**

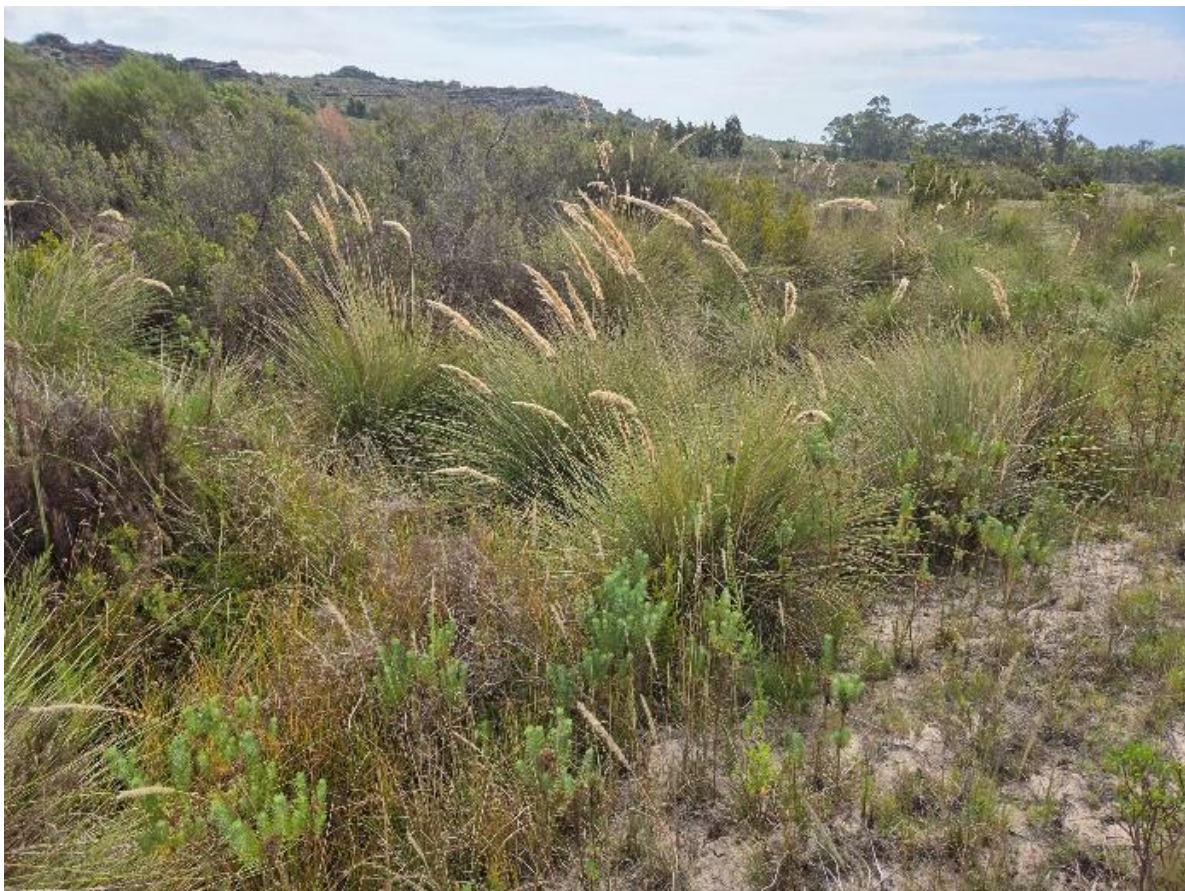
**Photograph 2**  
**Vegetation in Wetland Reach A (seep wetland)**

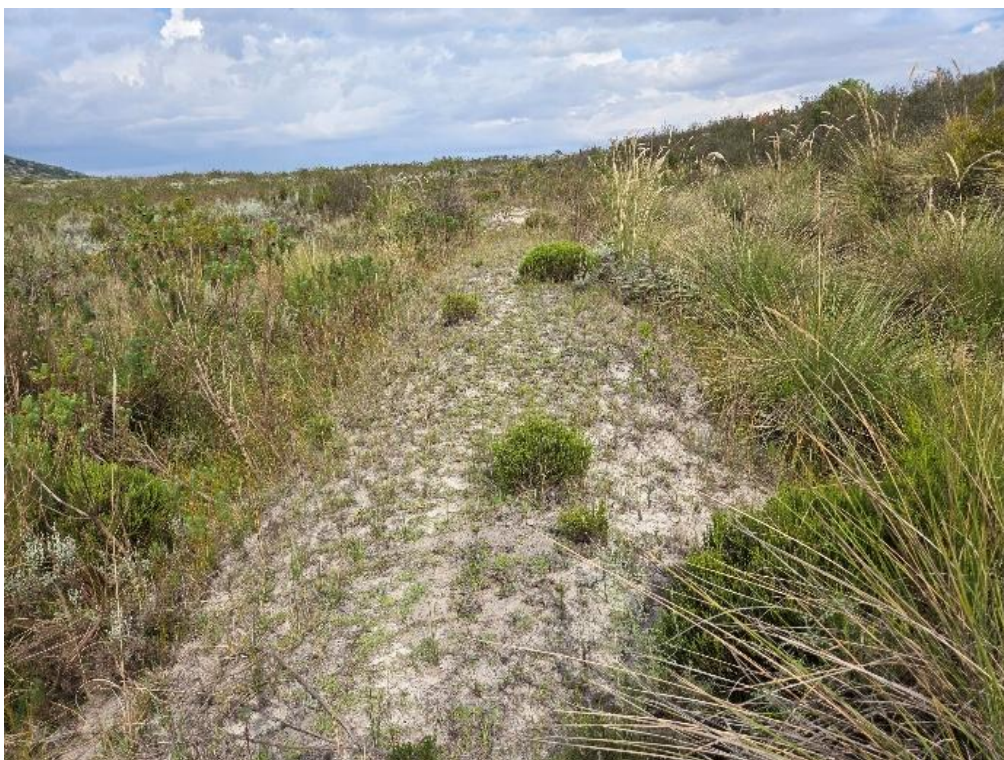
**Photograph 3**

**Impacted areas in Wetland Reach A (seep wetland) – agricultural berms redirect water flow**

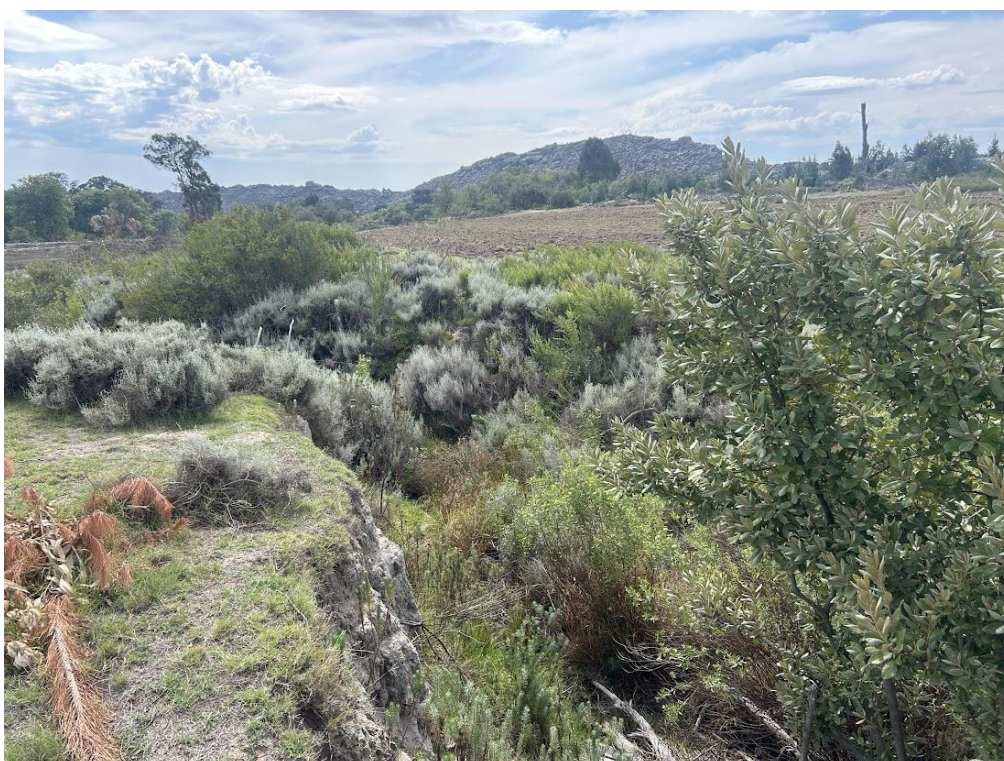
**Photograph 4**

**Incised / excavated channel downstream of road crossing through Wetland Reach A (seep wetland), concentrating flows and draining adjacent wetland seep areas.**

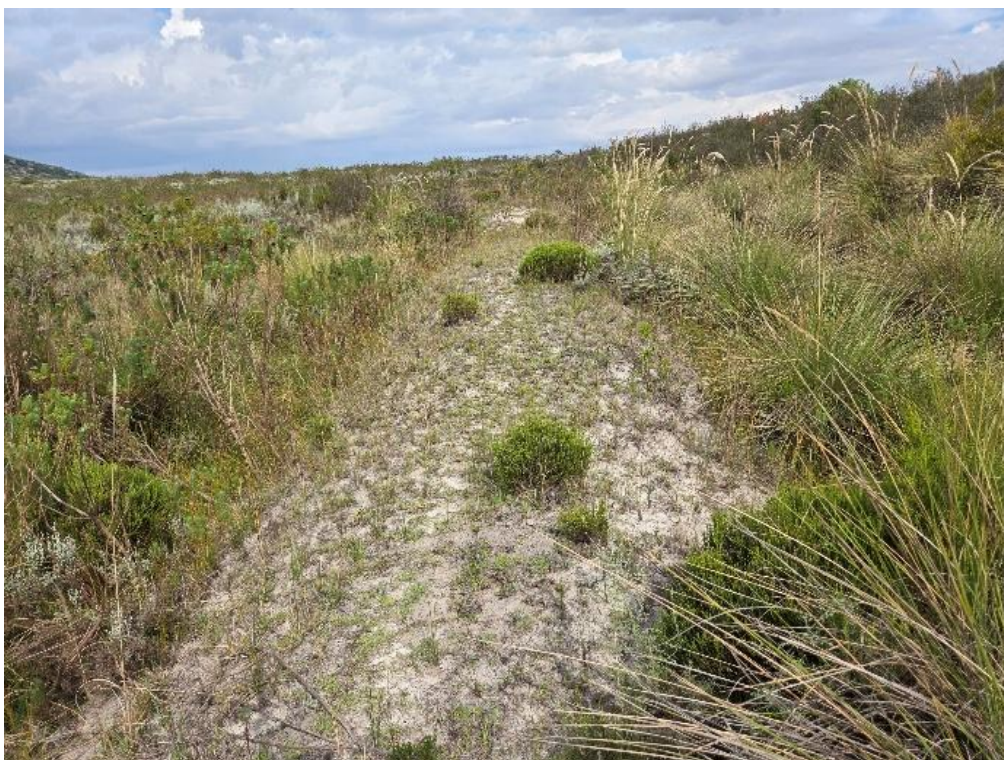
**Photograph 5**

**Impacted areas in Wetland Reach A (seep wetland) – agricultural berms redirect water flow**

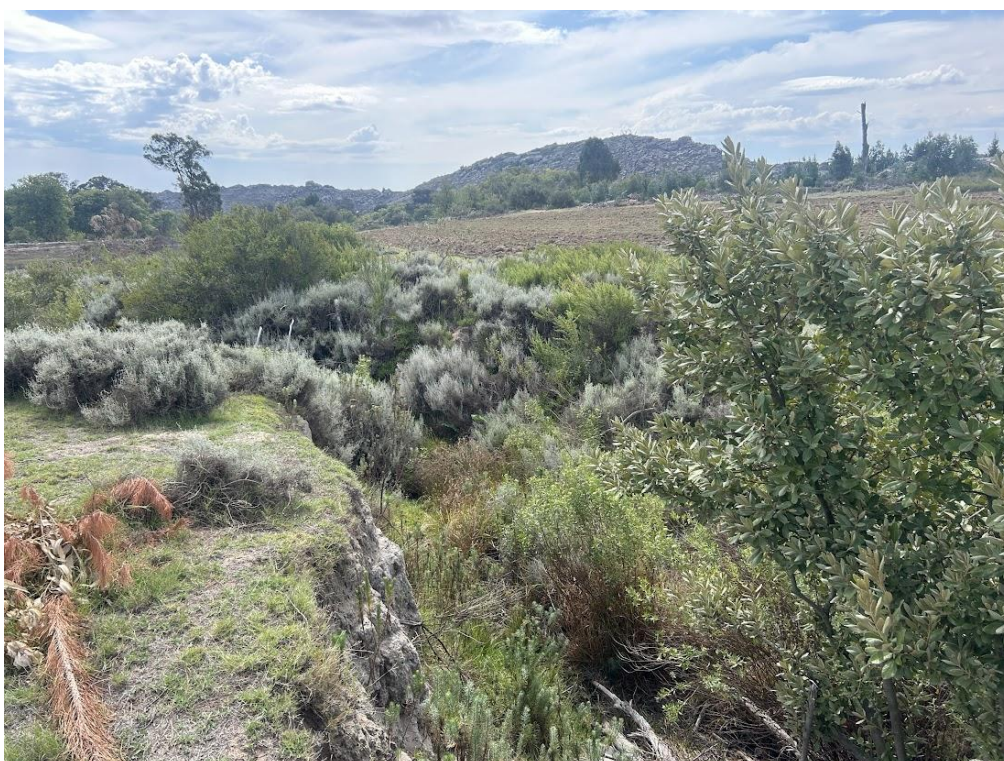
**Photograph 6**

**Incised / excavated channel downstream of road crossing through Wetland Reach A (seep wetland), concentrating flows and draining adjacent wetland seep areas.**

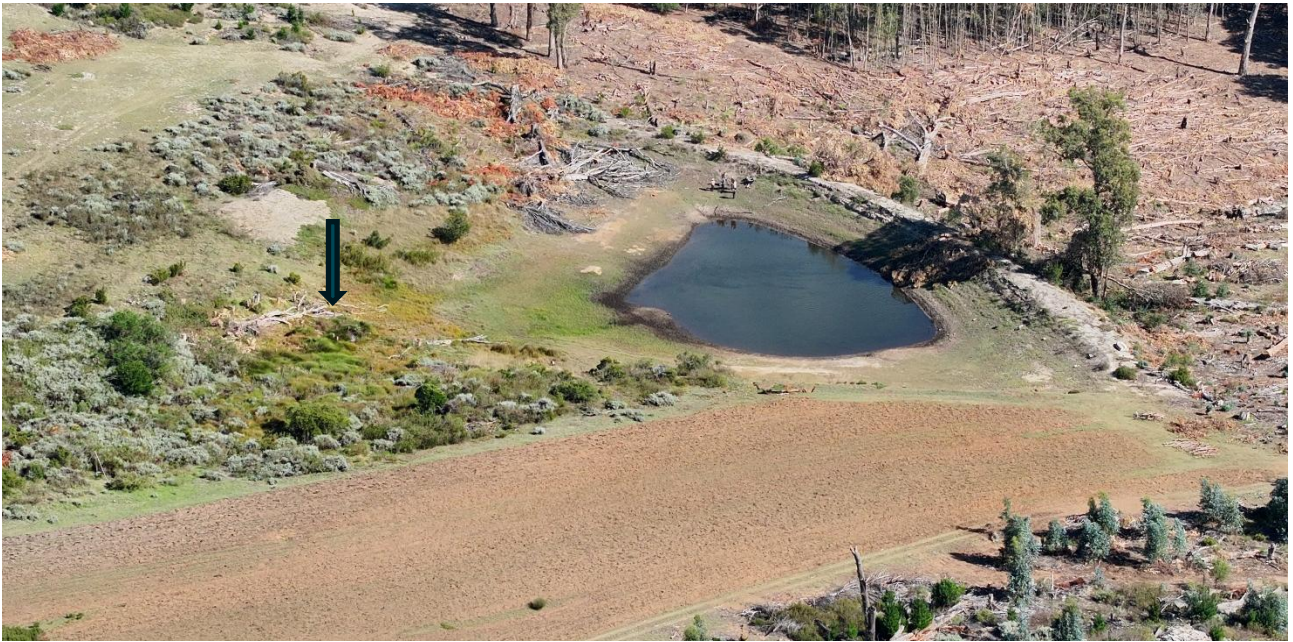
**Photograph 7**  
**Dam 1 viewed from the northeast**

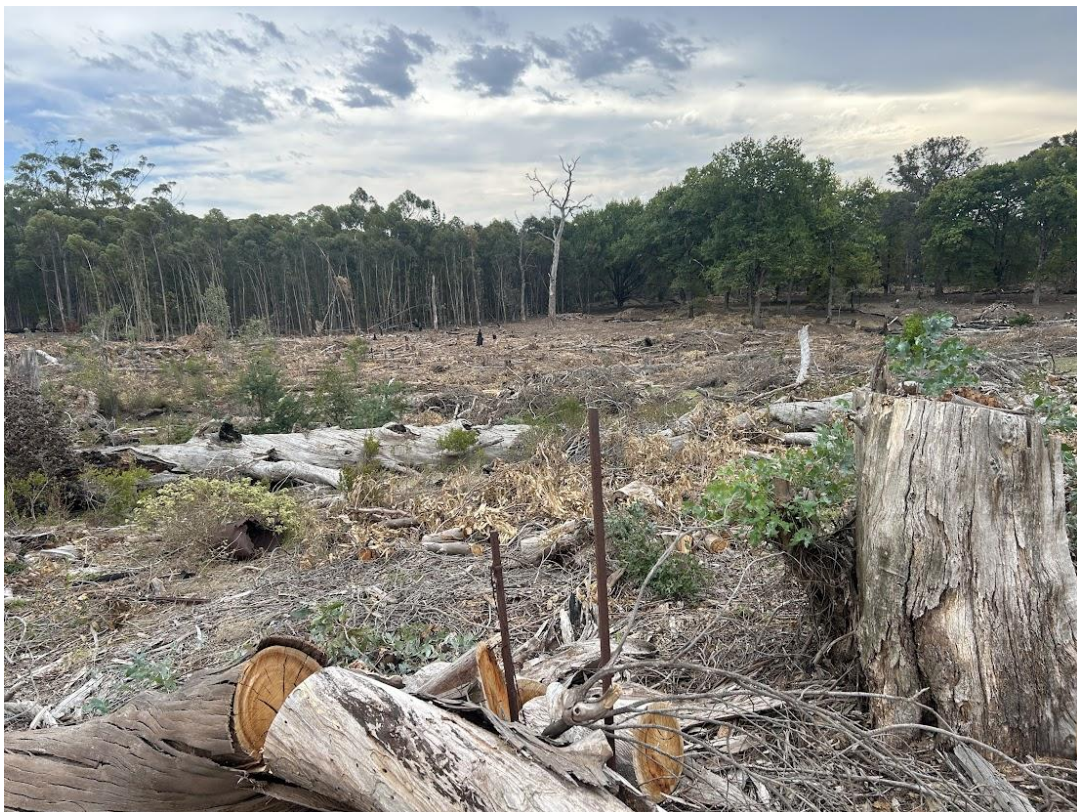
**Photograph 8**  
**Felled alien vegetation (pines and poplars) downstream of Dam 1 (Wetland Reach B)**

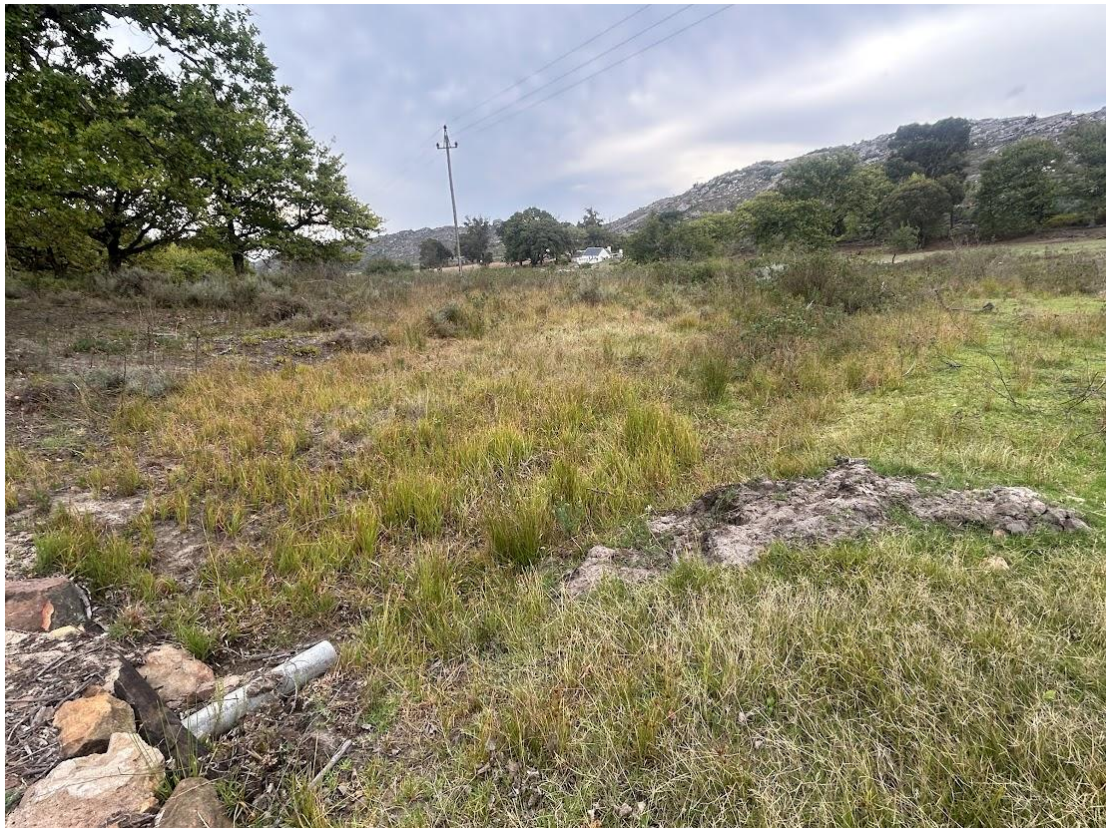
**Photograph 9**

**More defined channel along the western edge of Wetland Reach B towards Dam 2.**

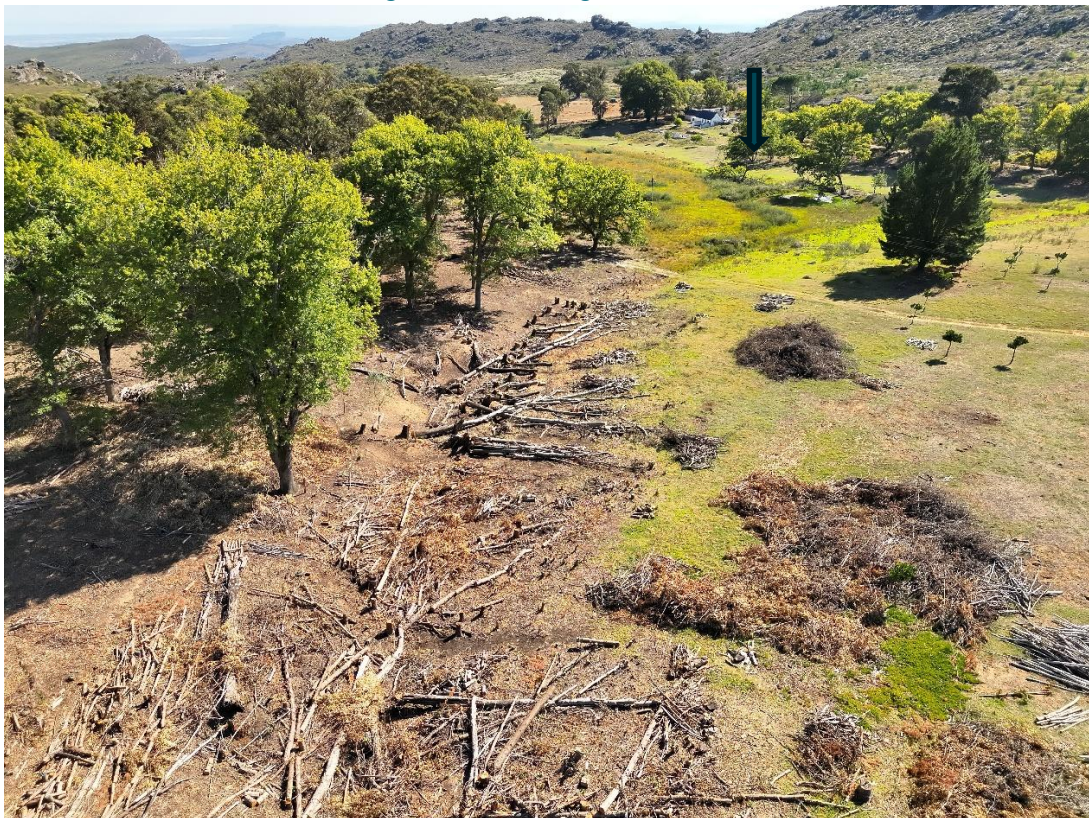
**Photograph 10**

**Wetland Reach B: Alien-cleared area between Dam 1 and Dam 2, with Dam 2 arrowed**

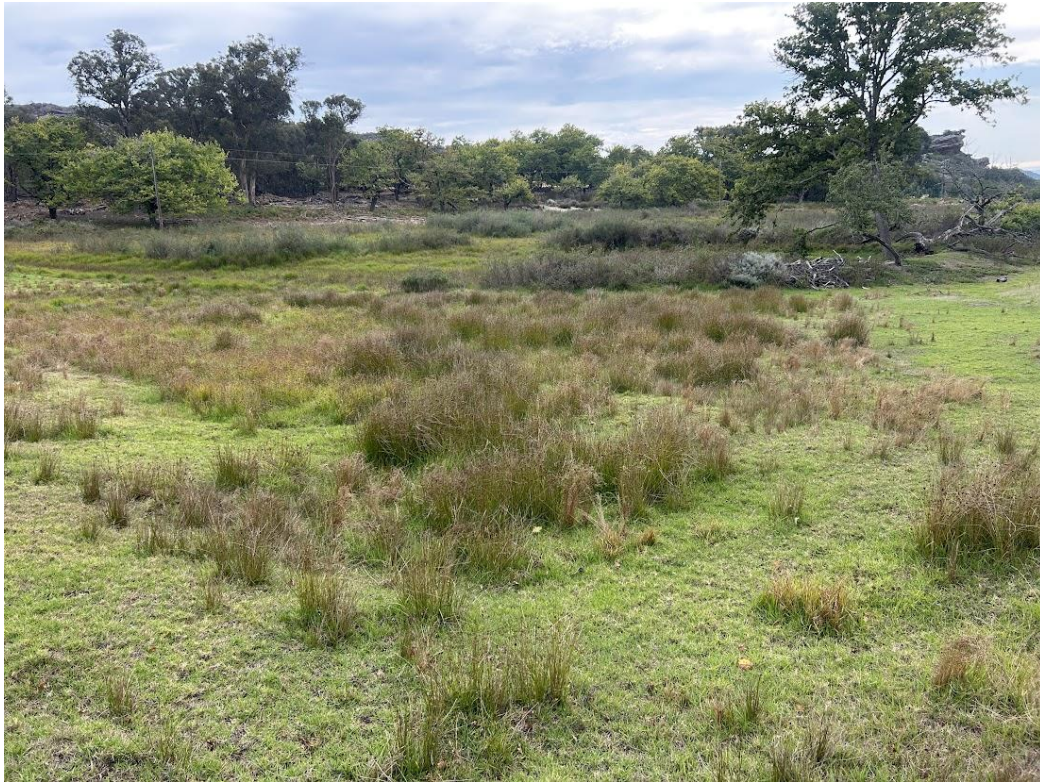
**Photograph 11**

**Wetland vegetation established upslope of Dam 2, with the influence of inflows from Side Seep B1 into Wetland Reach B shown in foreground (*Juncus kraussii* and *Ficinia nodosa*)**

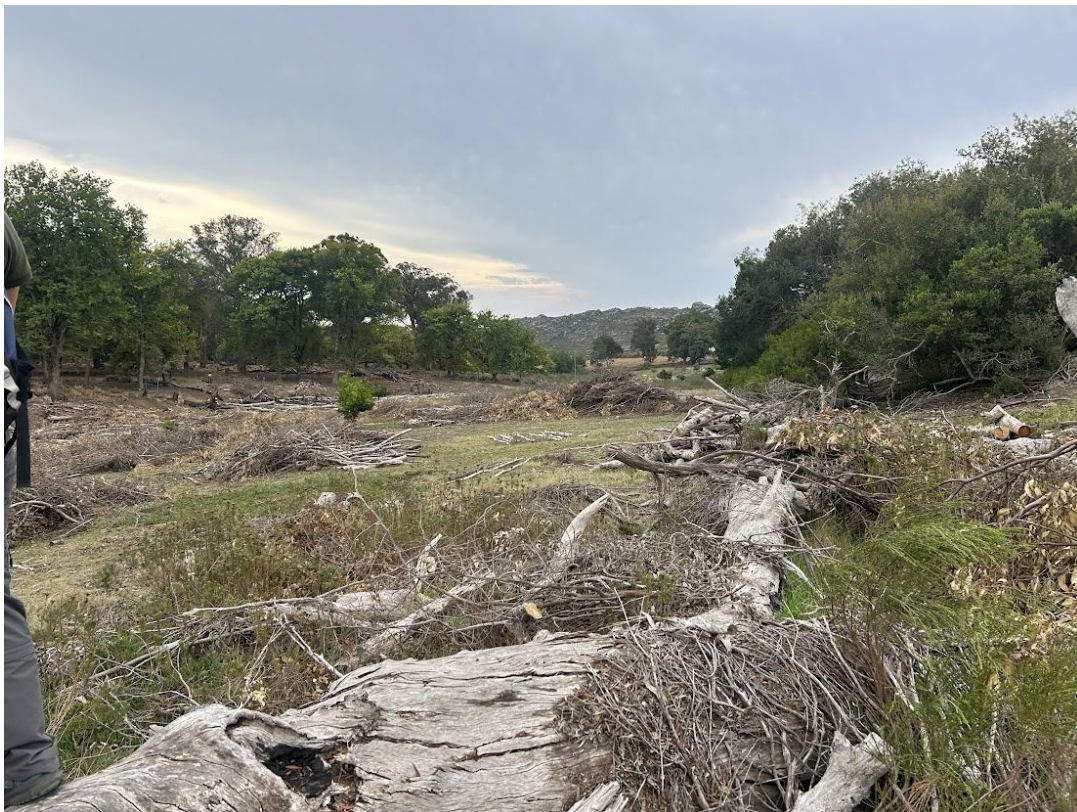
**Photograph 12**  
**Wetland Side Seep B1**

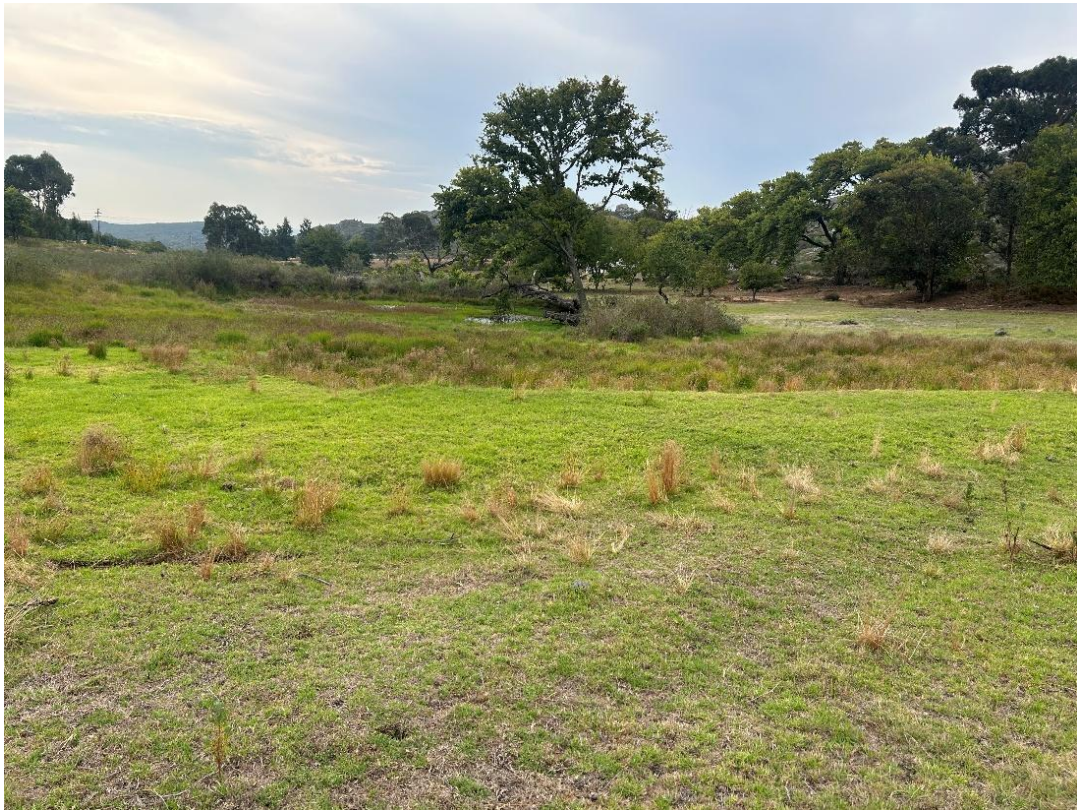
**Photograph 13**  
View downslope into Dam 2

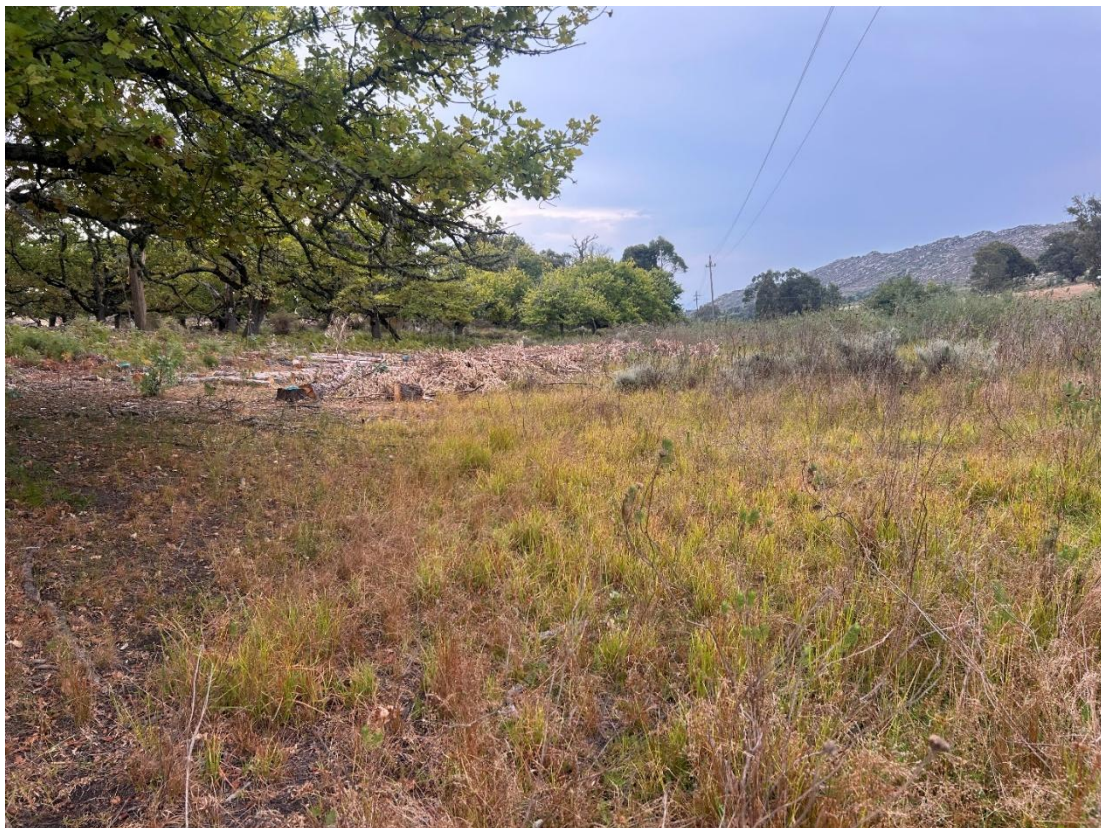
**Photograph 14**  
View along Wetland Reach C ("oak" wetland), downstream of Dam 2

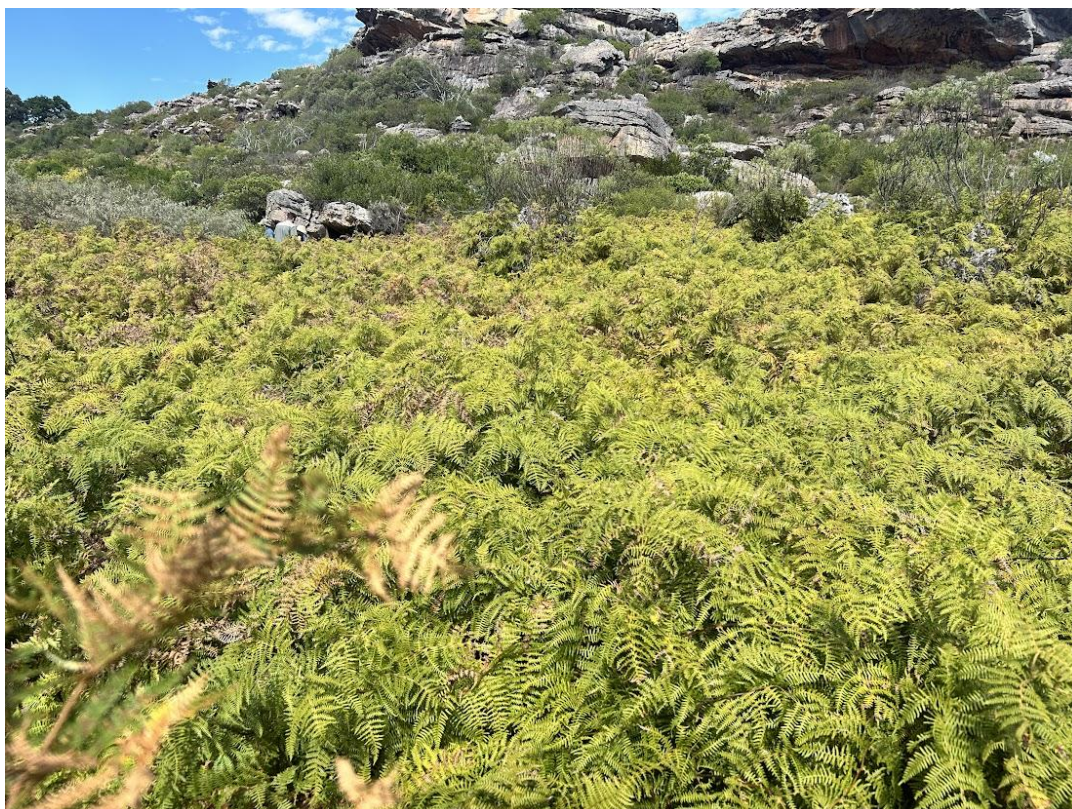
**Photograph 15**

*Pteridium aquilinum* (bracken fern) dominating the area above the incised channel comprising Wetland Reach D between Dam 3 and Dam 4

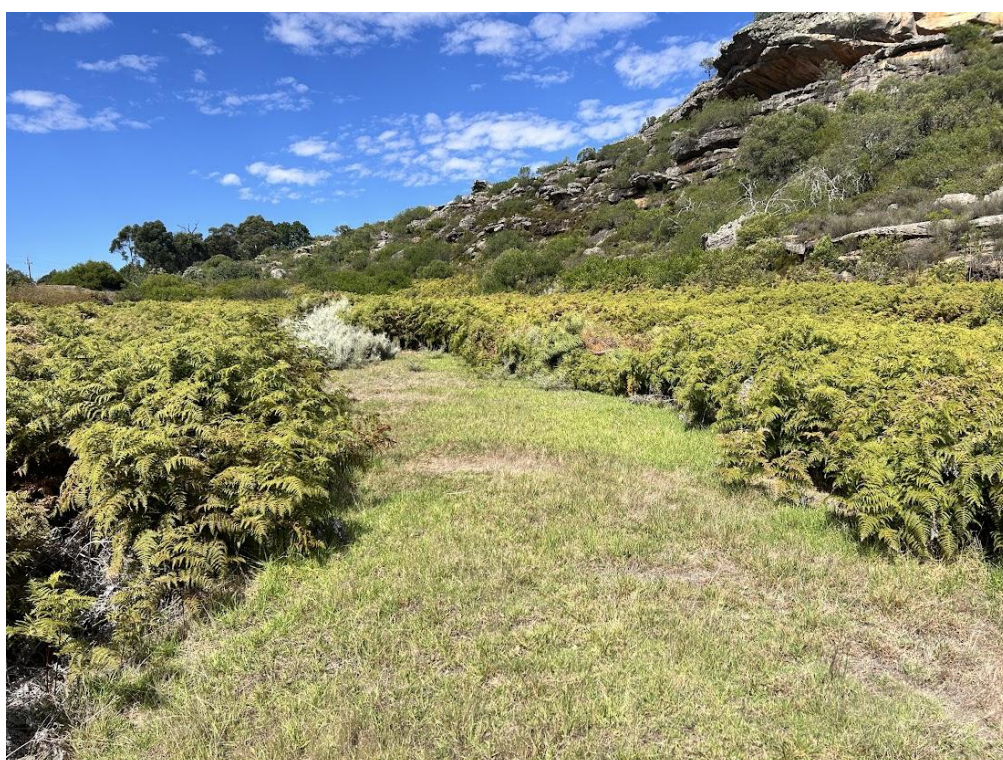
**Photograph 15**

*Pteridium aquilinum* (bracken fern) between Dam 3 and Dam 4, with grassed area of infill. Incised channel (Wetland Reach D) is to the left of this (upstream-facing) view.

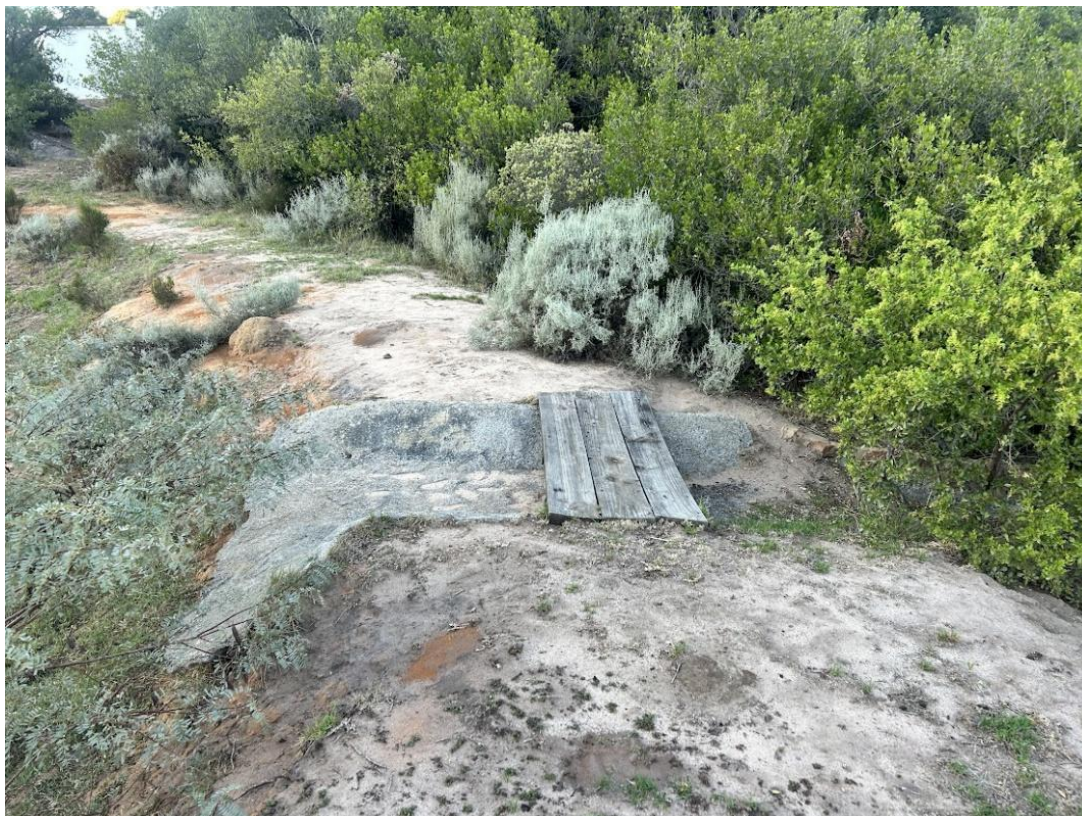
**Photograph 16**  
**Concrete spillway over the dam wall of Dam 4**

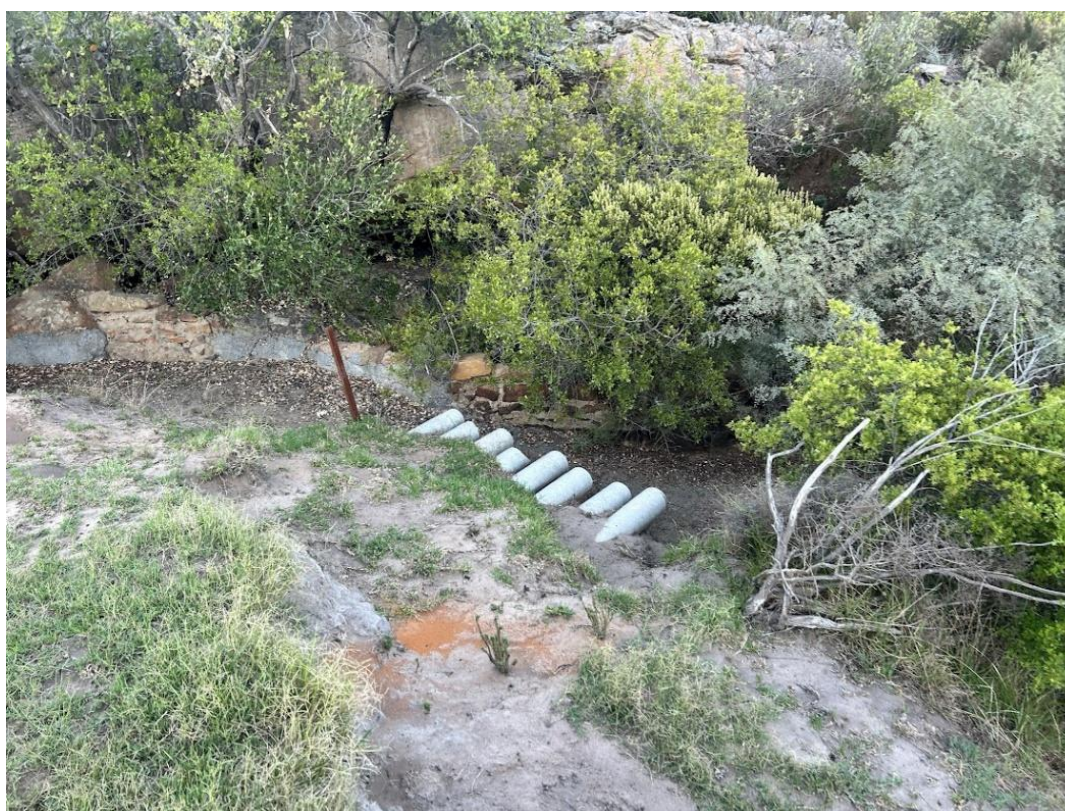
**Photograph 17**  
**Pipe outlets from Dam 4 into the concrete spillway**

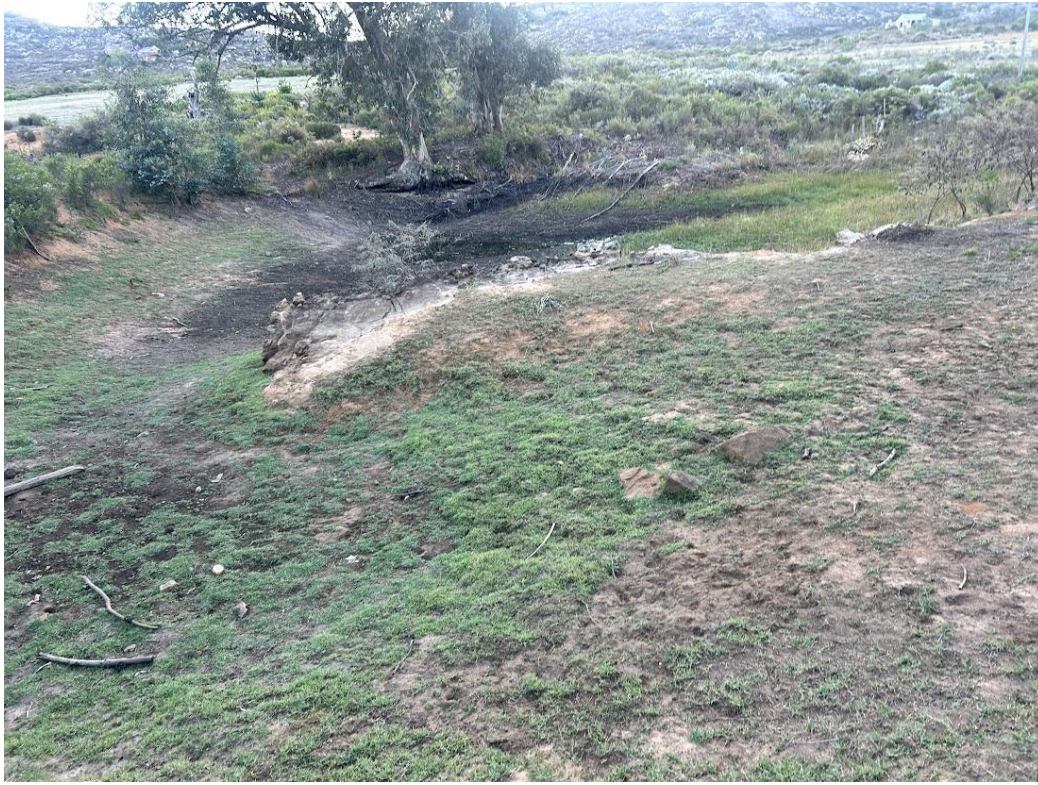
**Photograph 18**  
**Standing water in Dam 4 (April 2026)**

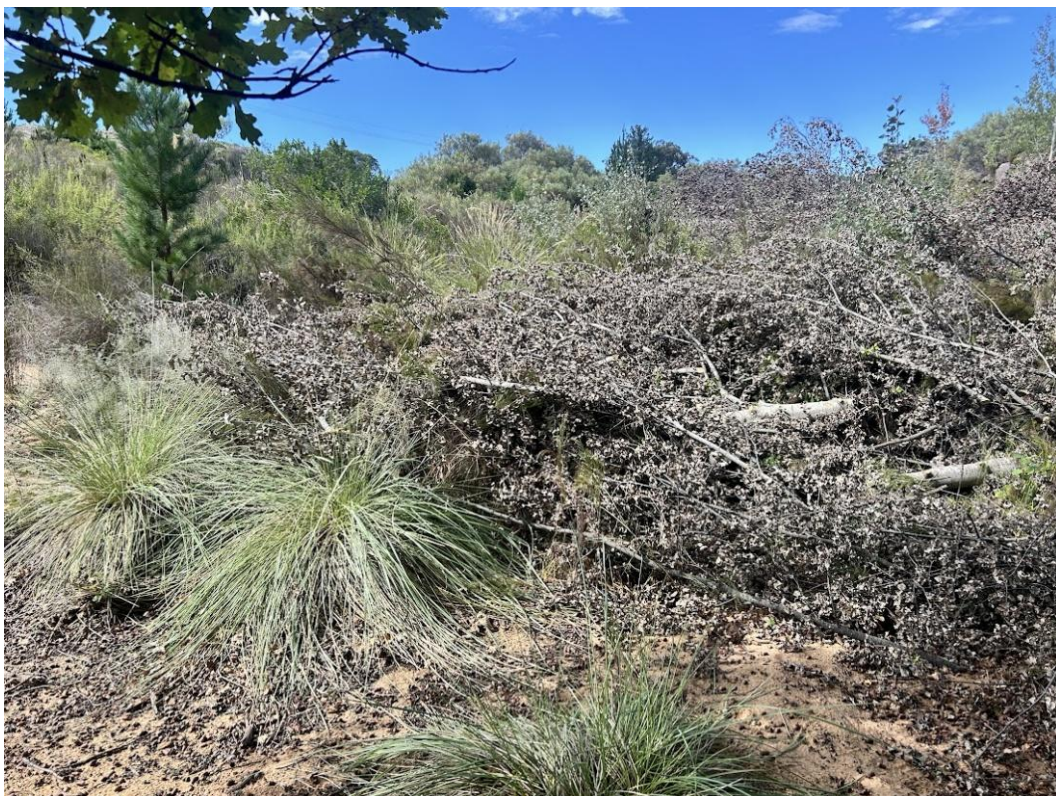
**Photograph 19**  
**Watercourse between Dam 4 and Dam 5 (April 2026)**

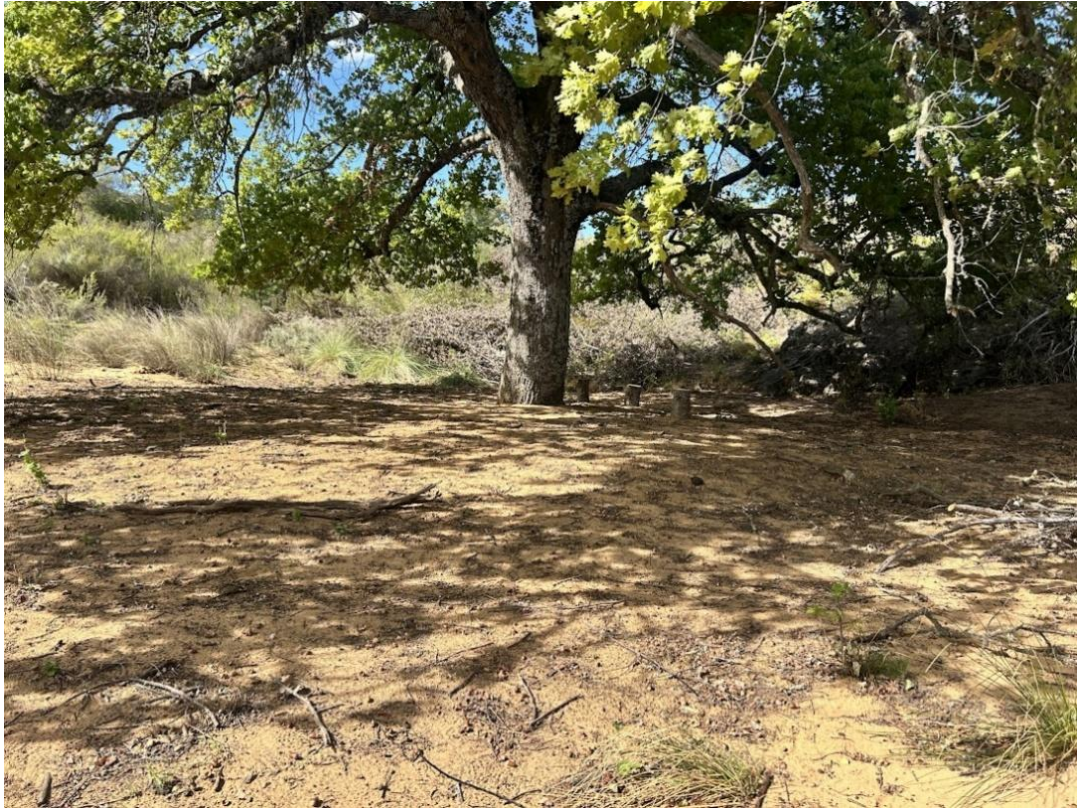
**Photograph 20**  
**Accumulated sediment in Dam 5 (April 2026)**

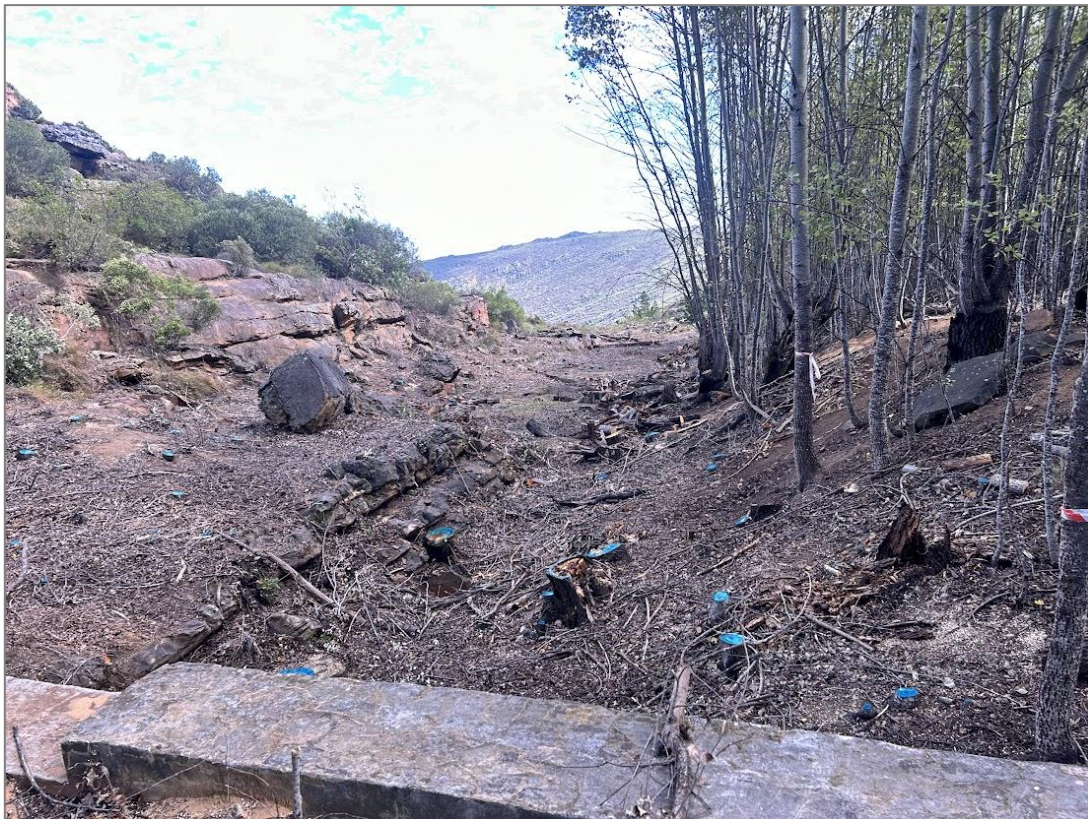
**Photograph 21**  
**Foothill stream downstream of Dam 5 (April 2026) – weir shown in foreground.**
