**PROPOSED WATERCOURSE REHABILITATION AND  
MANAGEMENT ACTIVITIES ON FARMS 15/37 AND RE/37  
(GROOTPLAAT), PIKETBERG, WESTERN CAPE PROVINCE**

**SPECIALIST AQUATIC ECOLOGIST  
IMPACT ASSESSMENT REPORT**

**DRAFT REPORT**

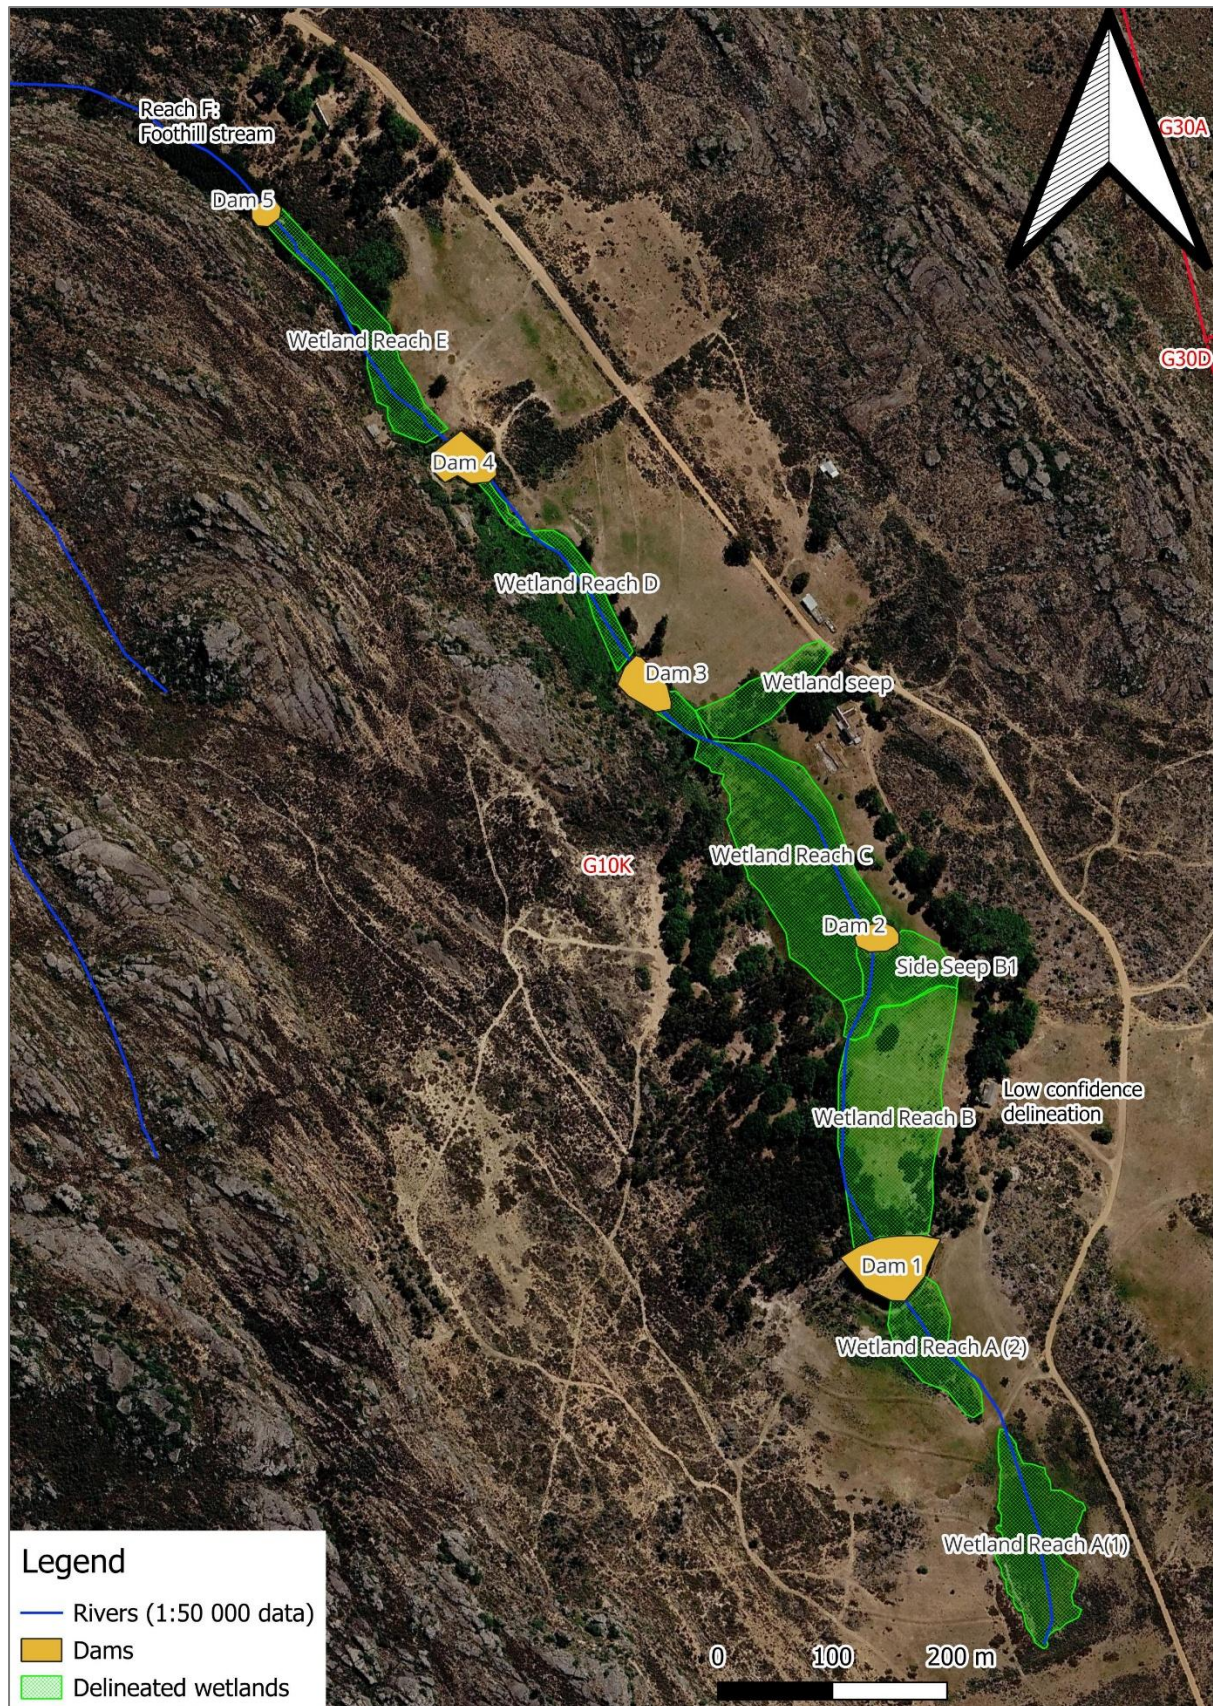
**Figure 2.5**  
**Wetlands and watercourses on the site, forming the focus of the rehabilitation plan assessed in this report.**

Figure 2.5 shows the watercourses delineated on the site in April 2026. These comprise hillslope seeps, in-channel dams, (naturally) unchanneled valley bottom wetlands, and mountain stream / foothill streams in the downstream reaches of the site. They are described briefly in the following sections.

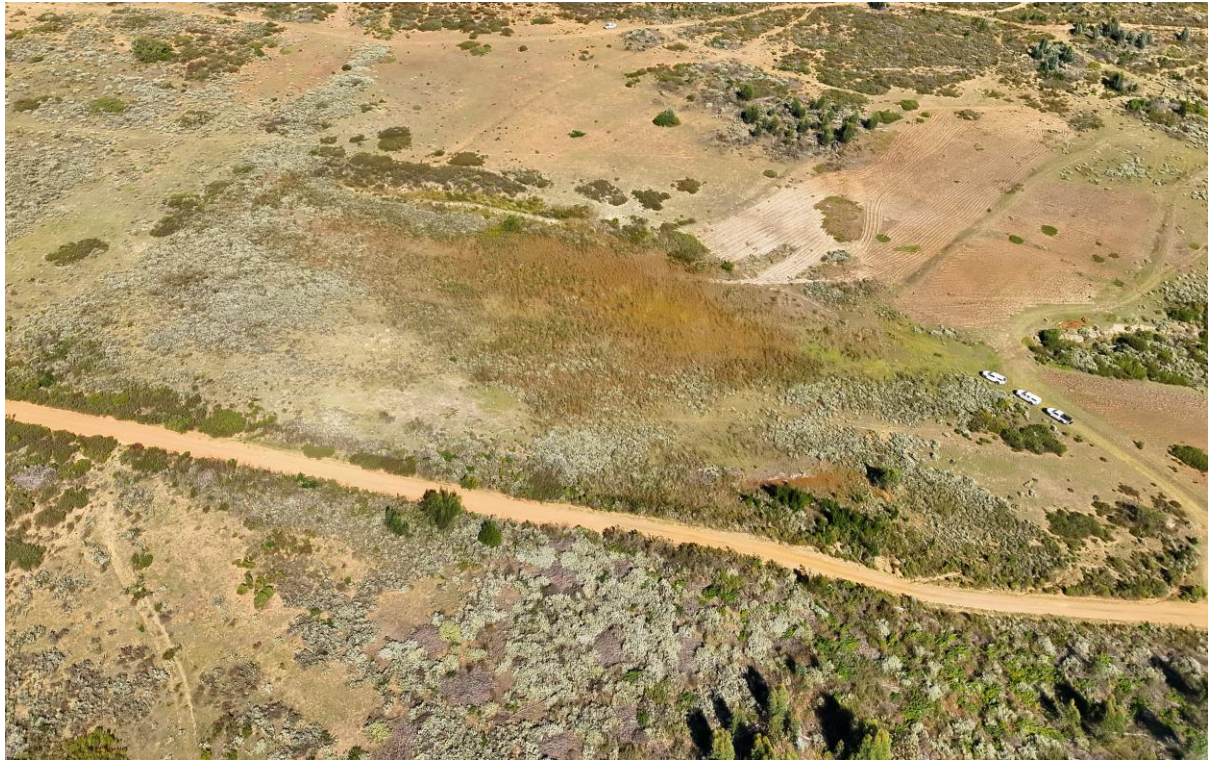
**Photograph 2-1**  
**Wetland Reach A (seep wetland) viewed from the north**

Watercourse PES has been estimated as PES Category C (moderately modified) upstream of the north-east to south-west access road (Wetland Reach A1), deteriorating to PES Category D/E downstream of the road (Wetland Reach A2).

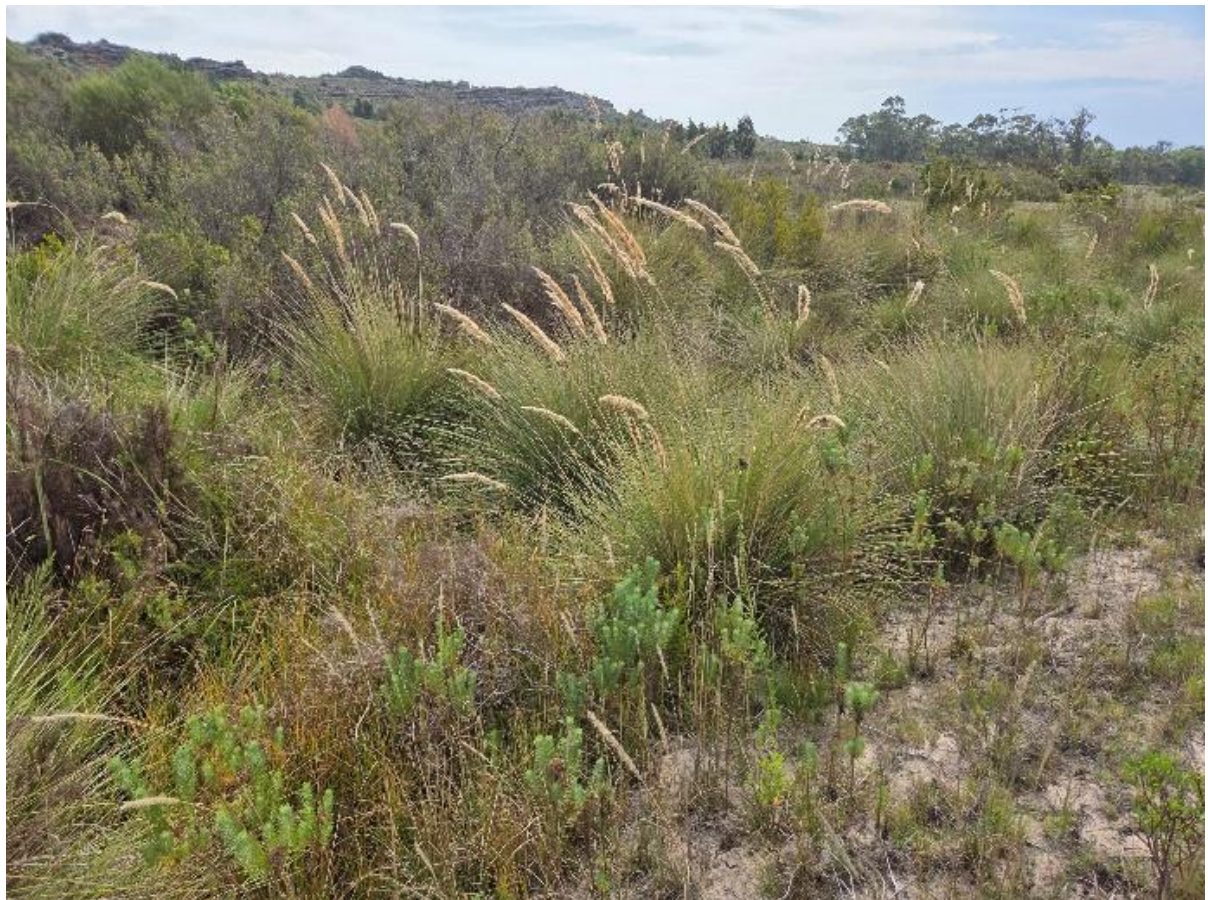
**Photograph 2.2**  
**Vegetation in Wetland Reach A (seep wetland) incl. *Merxmüllera* sp.**

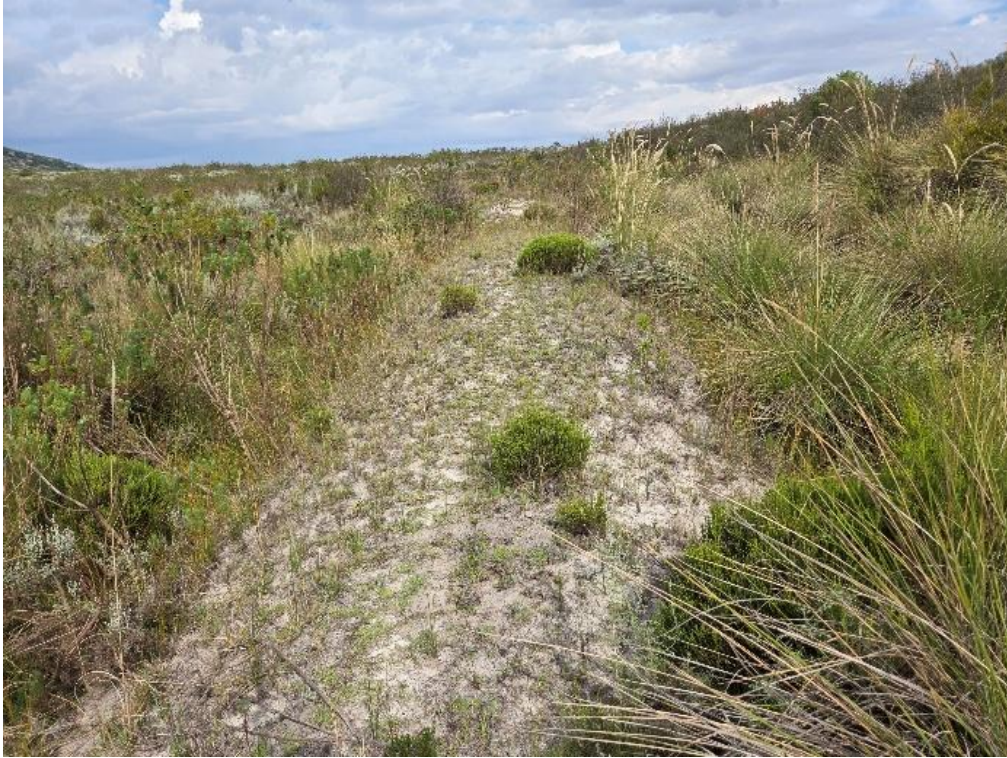
**Photograph 2.3**

**Impacted areas in Wetland Reach A (seep wetland) – agricultural berms redirect water flow**

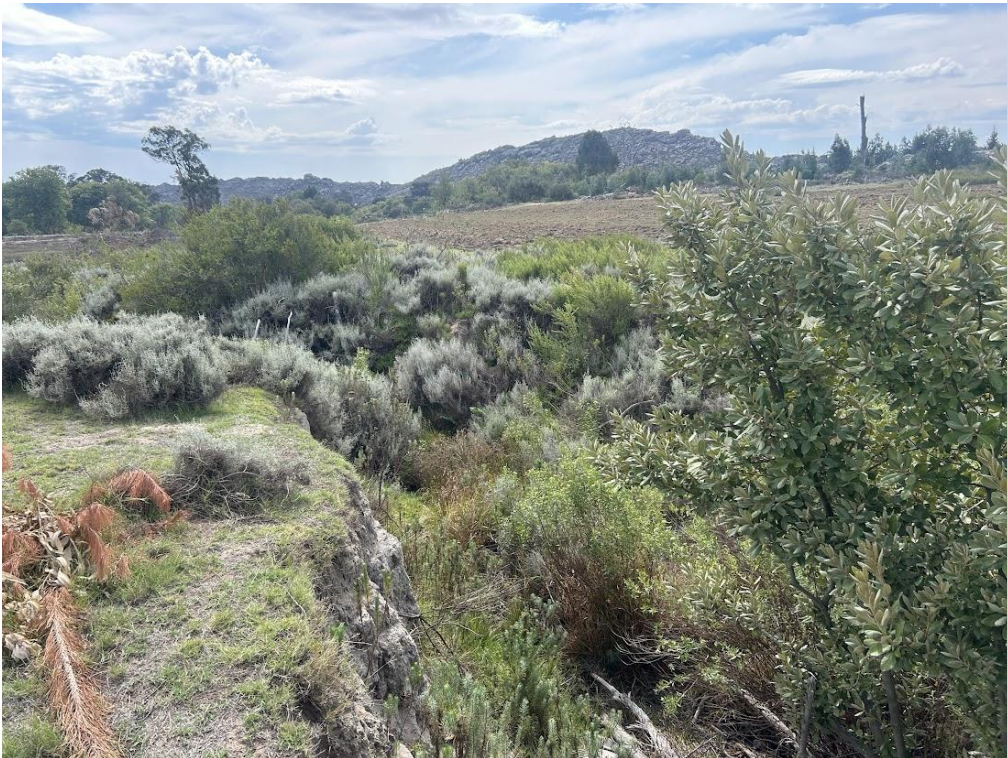
**Photograph 2.4**

**Incised / excavated channel downstream of road crossing through Wetland Reach A (seep wetland), concentrating flows and draining adjacent wetland seep areas.**

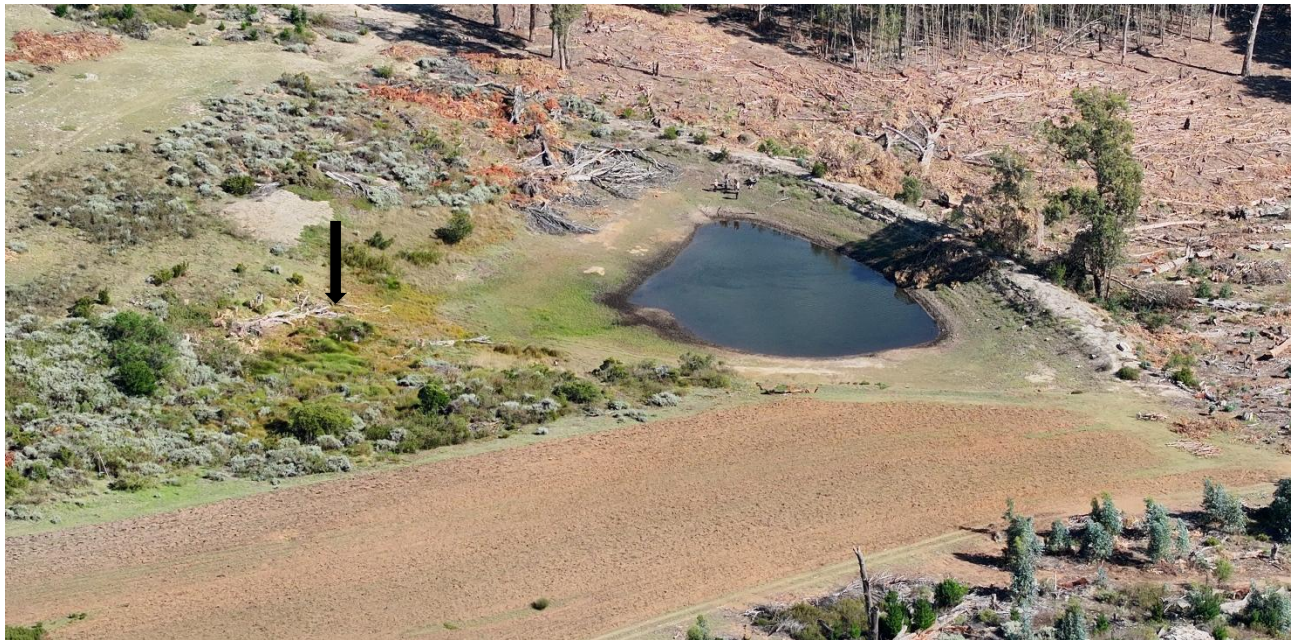
**Photograph 2.5**  
**Dam 1 viewed from the northeast**

The dam, shown in Photograph 2.5, comprises an earth-wall structure with a high-level overflow / spillway on its eastern side. The dam wall appears to be structurally compromised at present by large trees including invasive alien species. When fully inundated, it appears to inundate up to the level arrowed in Photograph 2.5, which is indicated by plant species typical of seasonal inundation. The lower parts of the dam are periodically deeply inundated and support limited plants, with few plant species able to survive the range in conditions from deep inundation to seasonal drought. Sago pondweed (*Stuckenia pectinata*) was observed in the dam during the April site visit.

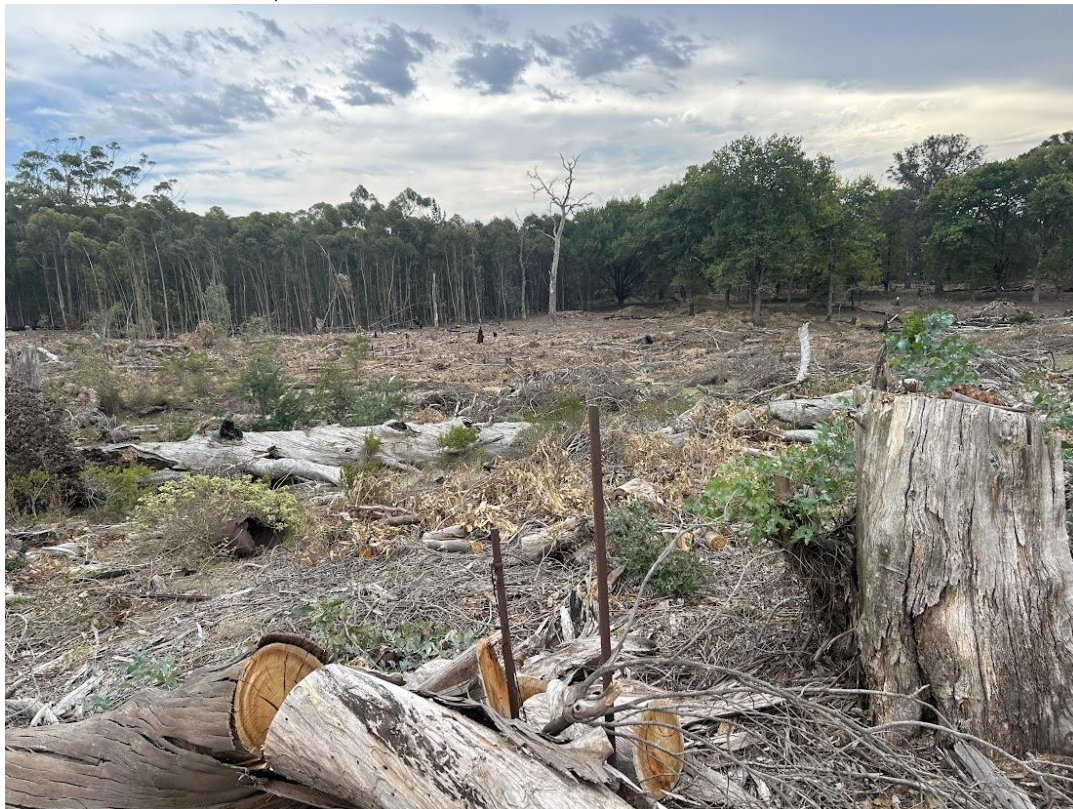
**Photograph 2.6**

**Felled alien vegetation (pines and poplars) downstream of Dam 1 (Wetland Reach B)**

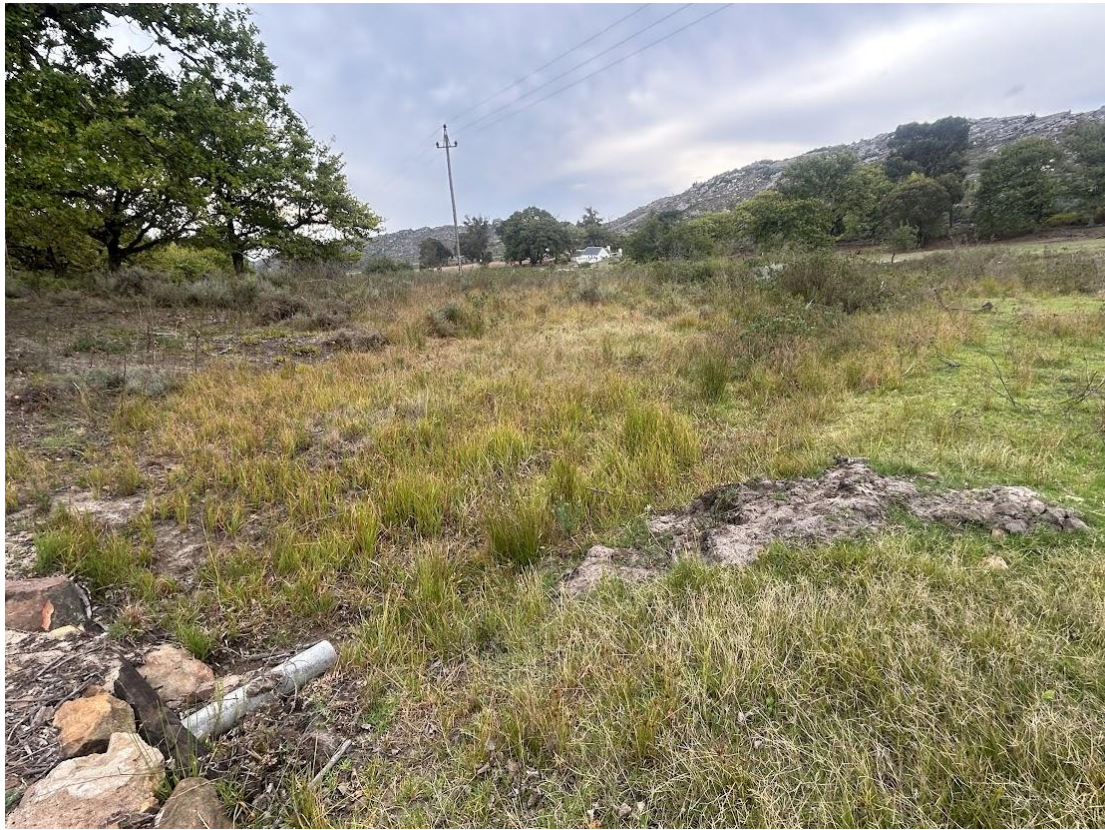
**Photograph 2.7**

**More defined channel along the western edge of Wetland Reach B towards Dam 2.**

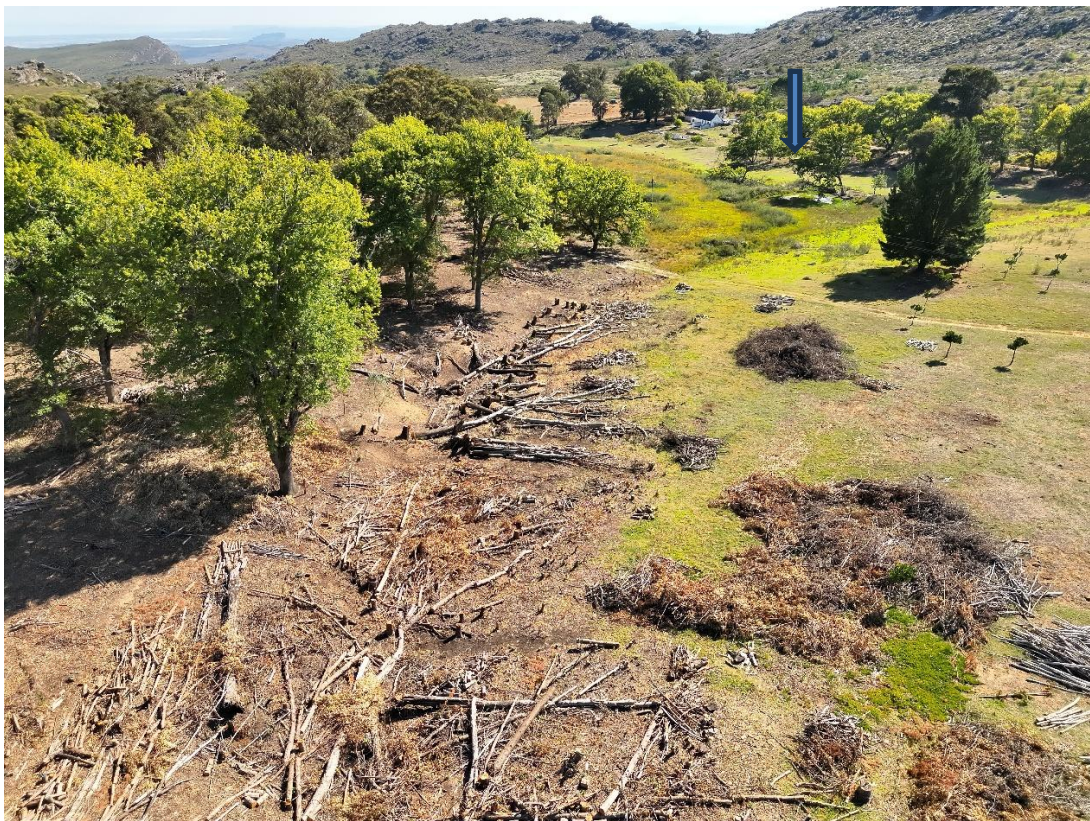
**Photograph 2.8**

**Wetland Reach B: Alien-cleared area between dam 1 and Dan 2, with Dam 2 arrowed**

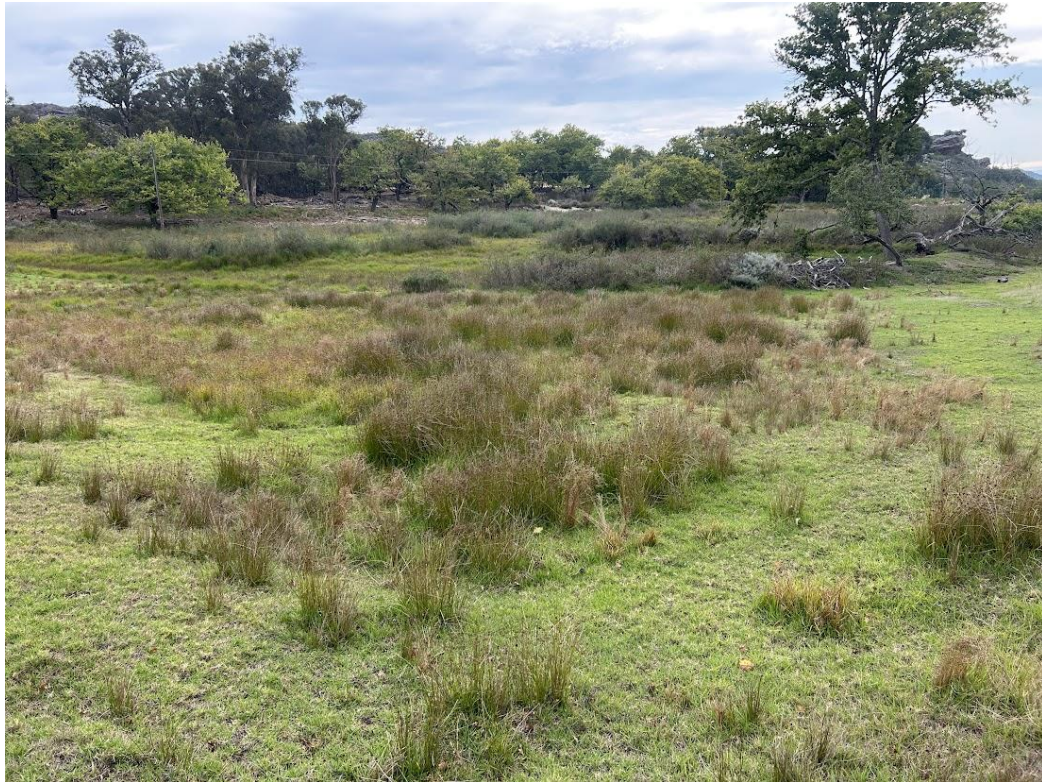
**Photograph 2.9**

**Wetland vegetation established upslope of Dam 2, with the influence of inflows from Side Seep B1 into Wetland Reach B shown in foreground (*Juncus kraussii* and *Ficinia nodosa*)**

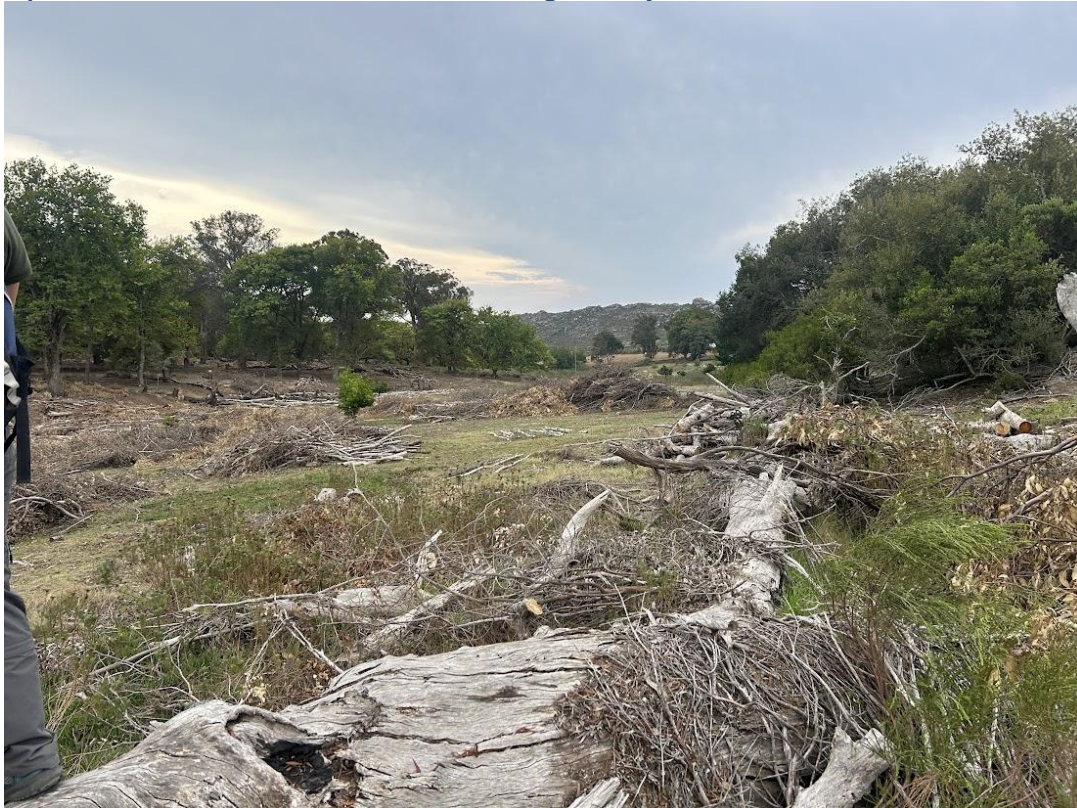
**Photograph 2.10**  
**Wetland Side Seep B1**

This seep has been briefly described in the previous section (see Photograph 2.10). It enters the main valley bottom wetland (Wetland Reach B) just upstream of Dam 2. Wetland vegetation along its flow path towards the Dam 2 berm and the western channel of the main river suggest that the seep receives regular seasonal discharge from its catchment to the west. Runoff from the adjacent access road also flows strongly down the seep line, bringing with it concentrated flows of water as well as silt and plant debris during rainfall events.

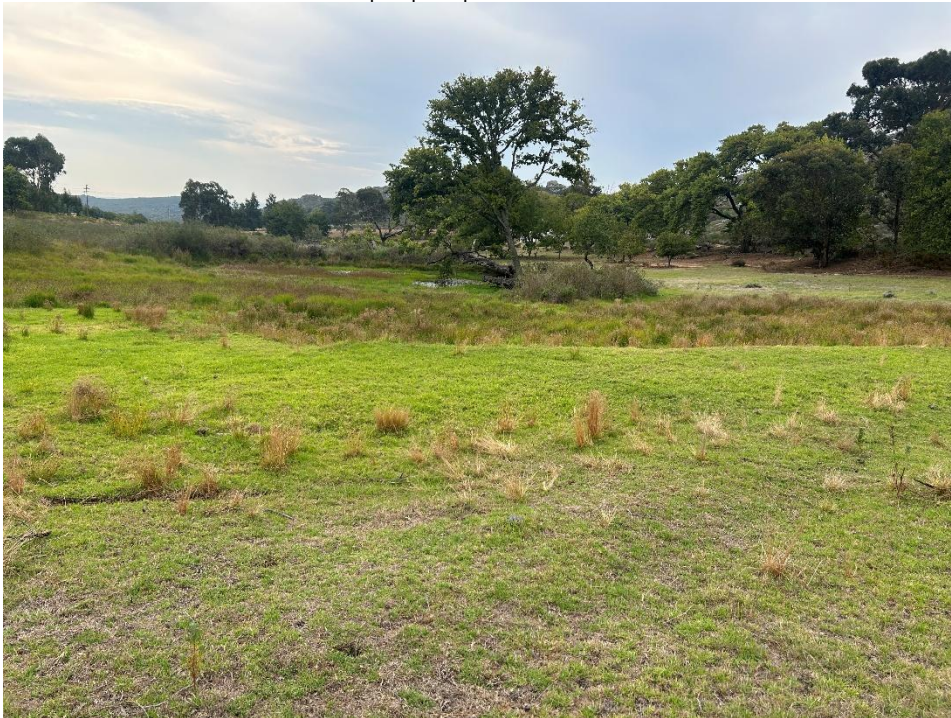
**Photograph 2.11**  
**View downslope into Dam 2**

This dam is a relatively small dam (see Photograph 2.11), surrounded by wetland vegetation which, it is assumed, has developed in response to the build-up of water in the dam and upslope of its surrounding berms and other flow impediments. The dam provides an aesthetically pleasing area and open water habitat, still present in late summer (April) 2026. It does however result in further shrinkage of what is assumed to have been a wide wetland area on this relatively flat valley bottom, with flows from Dam 2 to Dam 3 being confined in a narrow wetland channel, running along the western side of the valley, and with clear droughting of the area downstream of the dam, along the eastern side of the valley floor. Inflows from Side Seep B1 enter the dam and/or build up upslope of the dam.

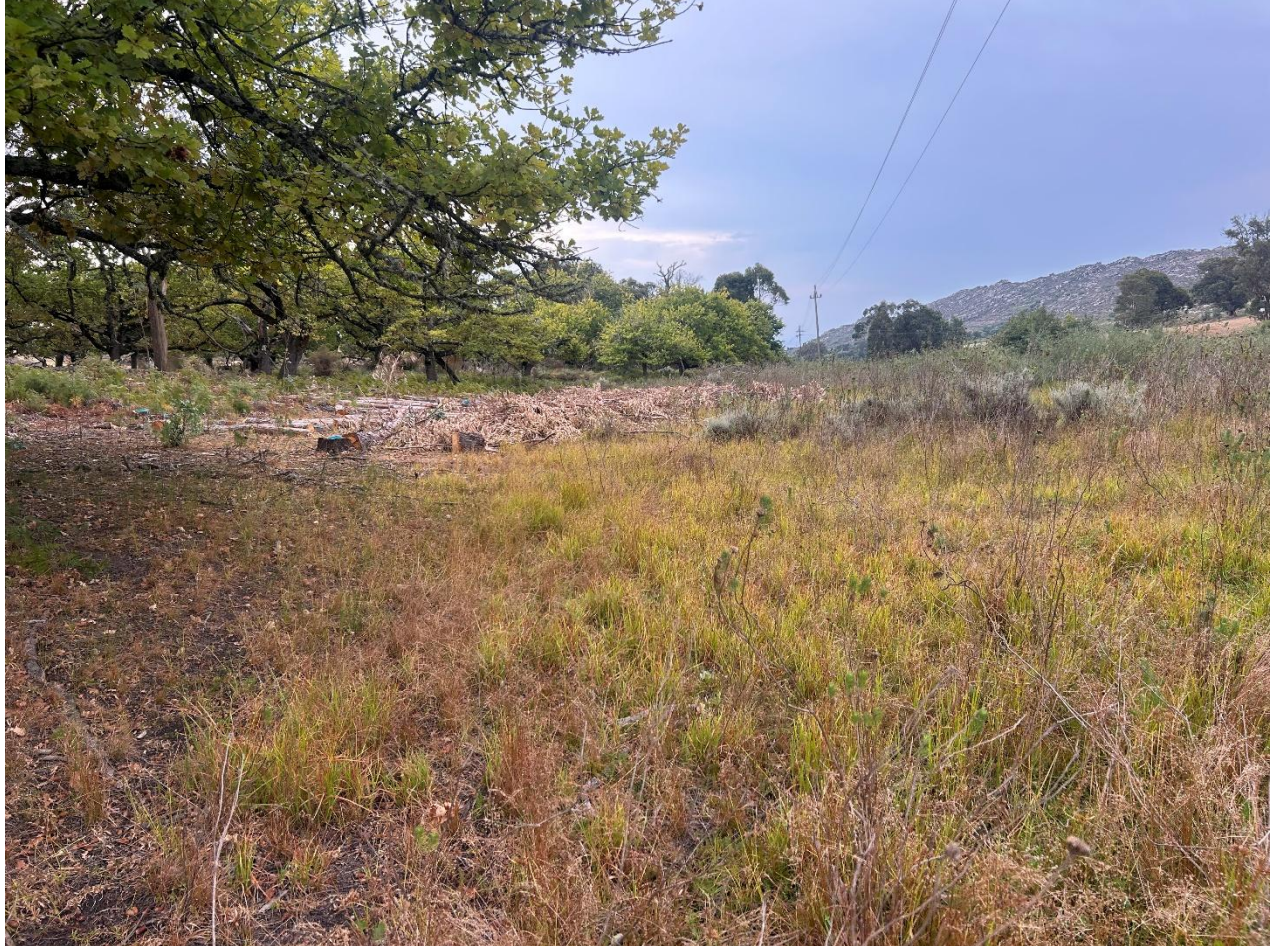
Downstream of Dam 2, the watercourse continues as a naturally unchanneled valley bottom wetland, although upstream impoundment and abstraction have severely impacted on assumed natural valley bottom wetland extent and character, with the wetland now being channelled along the western edge of the valley floor; in places difficult to identify; and furthermore impacted by cut-off channels, parallel with the hillslope contours; alien vegetation (being cutdown at the time of the April 2026 site visit) (see Photograph 2.12). The delineated wetland was marked by scattered *Merxmuellera* sp., with *Pteridium aquilinum* (considered a facultative rather than an obligate wetland species) occurring on alien-cleared slopes leading

into the delineated wetland area, demarcated primarily on the basis of the extent of *Pteridium aquilinum*, *Ficinia nodos* and *Cenchrus macrourus*. Seepage into the wetland from the hillslopes to the west is assumed and these inflows are assessed as very important for sustaining this watercourse, albeit in a highly impacted condition, with changes (decreases) in surface and through-flows; alien vegetation; loss of indigenous vegetation and changes in wetland / river channel morphology being the major impacts identified. Together, these changes mean that this reach of the watercourse (Dam 2 to Dam 3) has been assessed as PES Category D.

**Photograph 2.12**  
**View along Wetland Reach C ("oak" wetland), downstream of Dam 2**

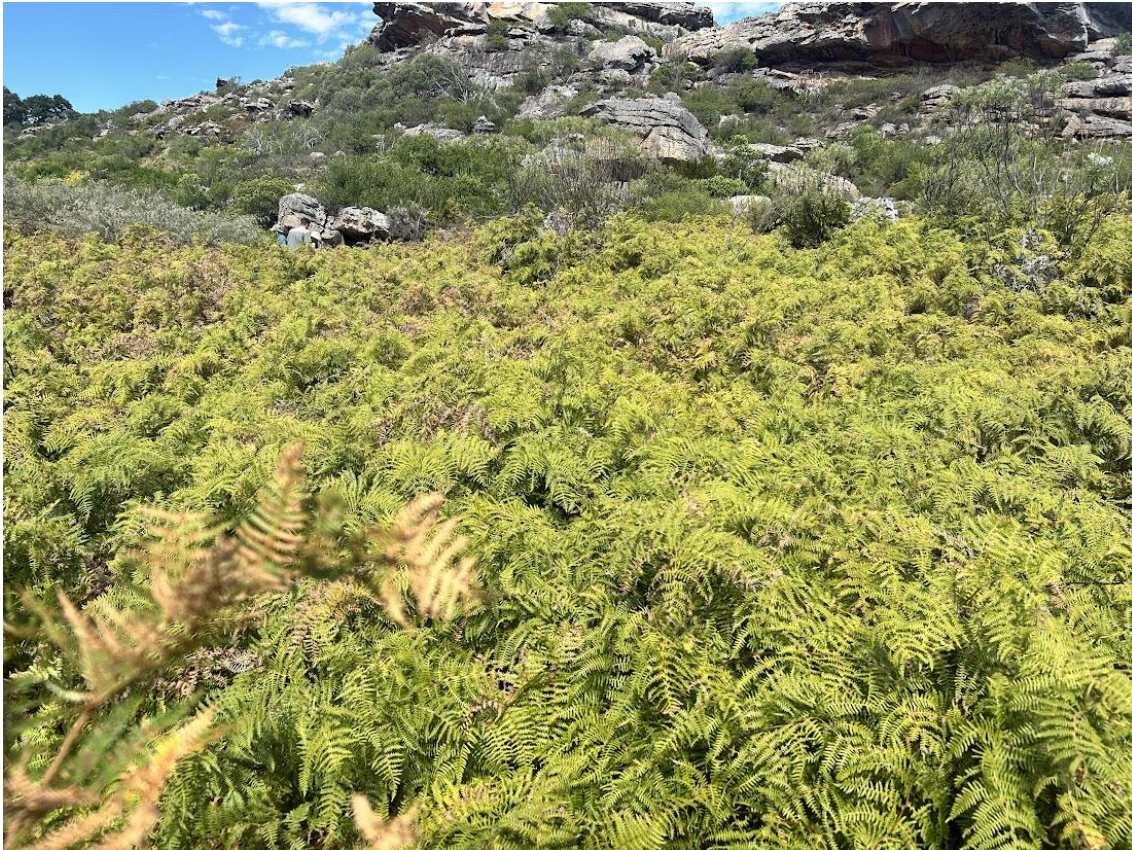
**Photograph 2.13**  
***Pteridium aquilinum* (bracken fern) dominating the area above the incised channel comprising Wetland Reach D between Dam 3 and Dam 4**

channel effectively drains the natural valley bottom wetland that should have occurred in these reaches, with the result that while the channel itself is vegetated with wetland obligates such as *Carex sp.*, *Psoralea affinis*, *Juncus kraussii*, *Juncus lomatophyllus* and *Ficinia nodosa*, these incised margins give way to dense stands of *Pteridium aquilinum* (bracken fern), which dominate the surrounding area. An area of the higher-lying valley bottom between the incised channel and the stands of *Pteridium aquilinum* appears to have been infilled and comprises a kikuyu grassed area, assumed to have been created to support livestock grazing in this area in the past (see Photographs 2.13 and 2.14).

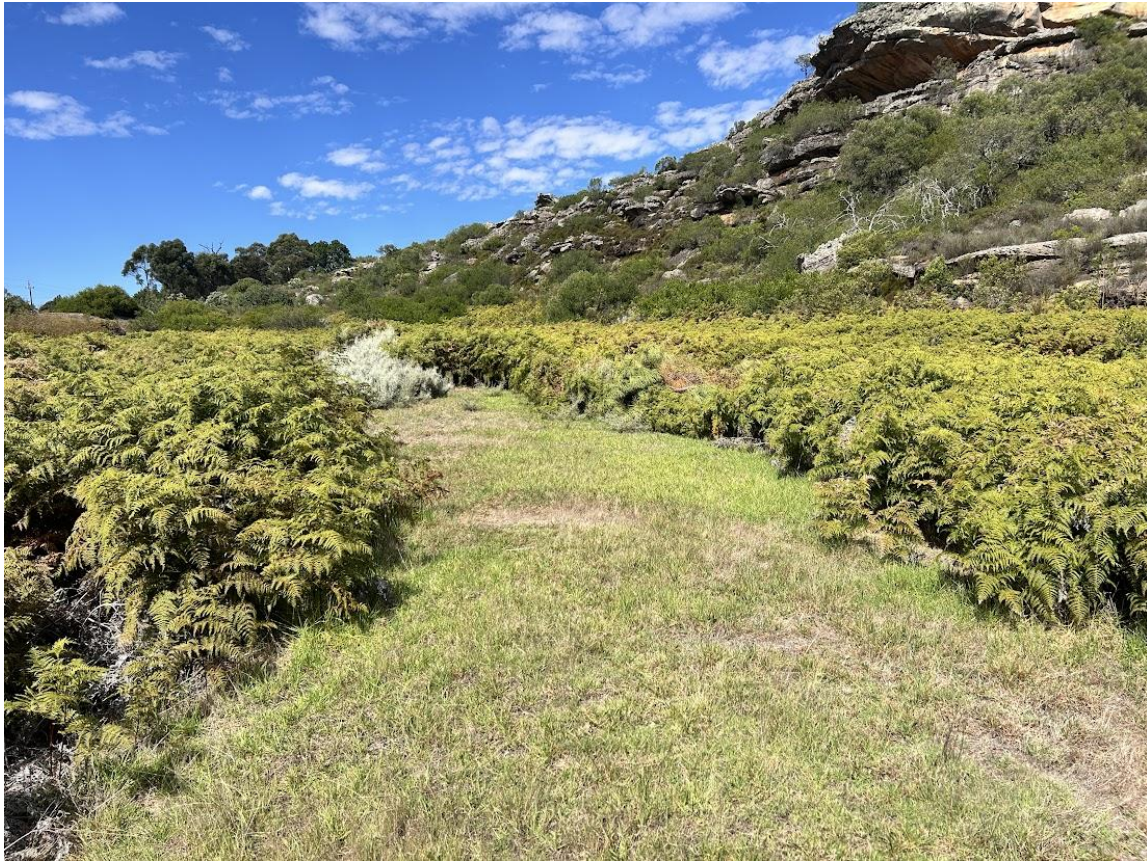
**Photograph 2.14**

***Pteridium aquilinum* (bracken fern) between Dam 3 and Dam 4, with grassed area of infill. Incised channel (Wetland Reach D) is to the left of this (upstream-facing) view.**

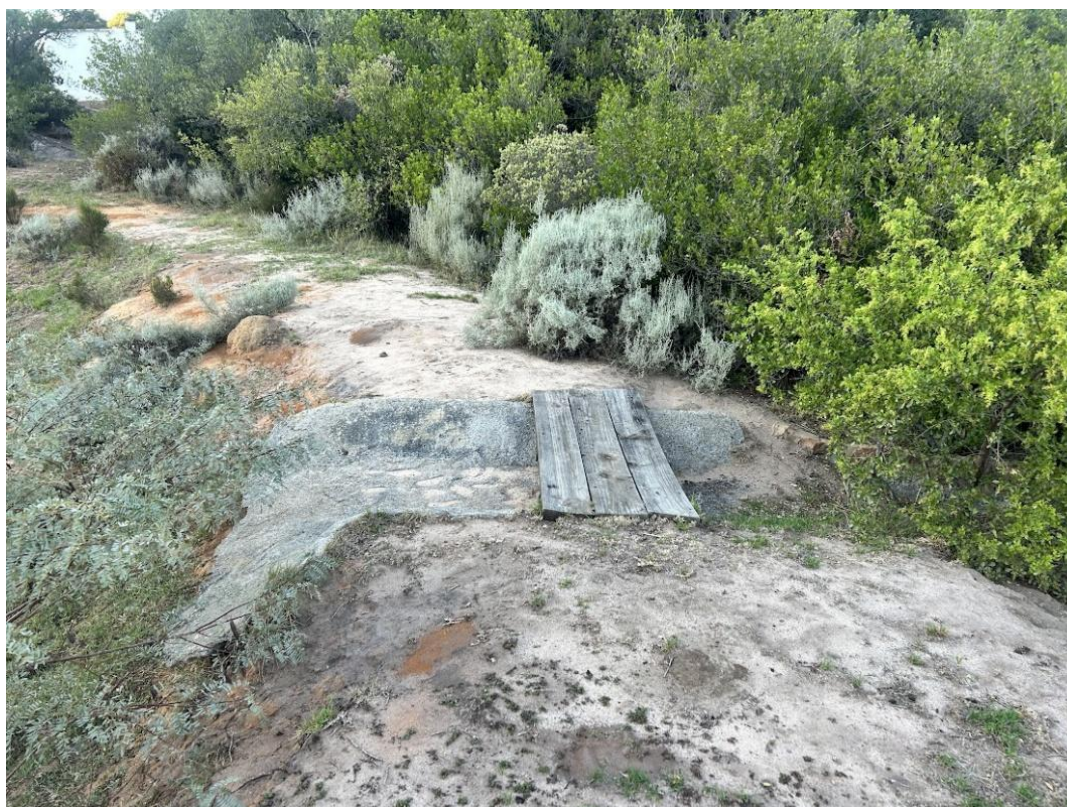
**Photograph 2.13**  
**Concrete spillway over the dam wall of Dam 4**

This dam (illustrated in Photographs 2.13 to 2.15) comprises an in-channel dam, with a concrete spillway and eight pipe outlets onto the concrete spillway overflow area. The dam was largely empty at the time of the April 2026 site visit, but included a small area of standing water on its north eastern edge, which was assumed to be groundwater-fed rather than fed by surface flows from the highly impounded upstream reaches. The wetter lower-lying portions of the dam were vegetated by indigenous wetland species such as *Ficinia nodosa*, *Juncus kraussii*, *Juncus capensis* and *Juncus lomatophyllus*, extending upslope from the inundated depression.

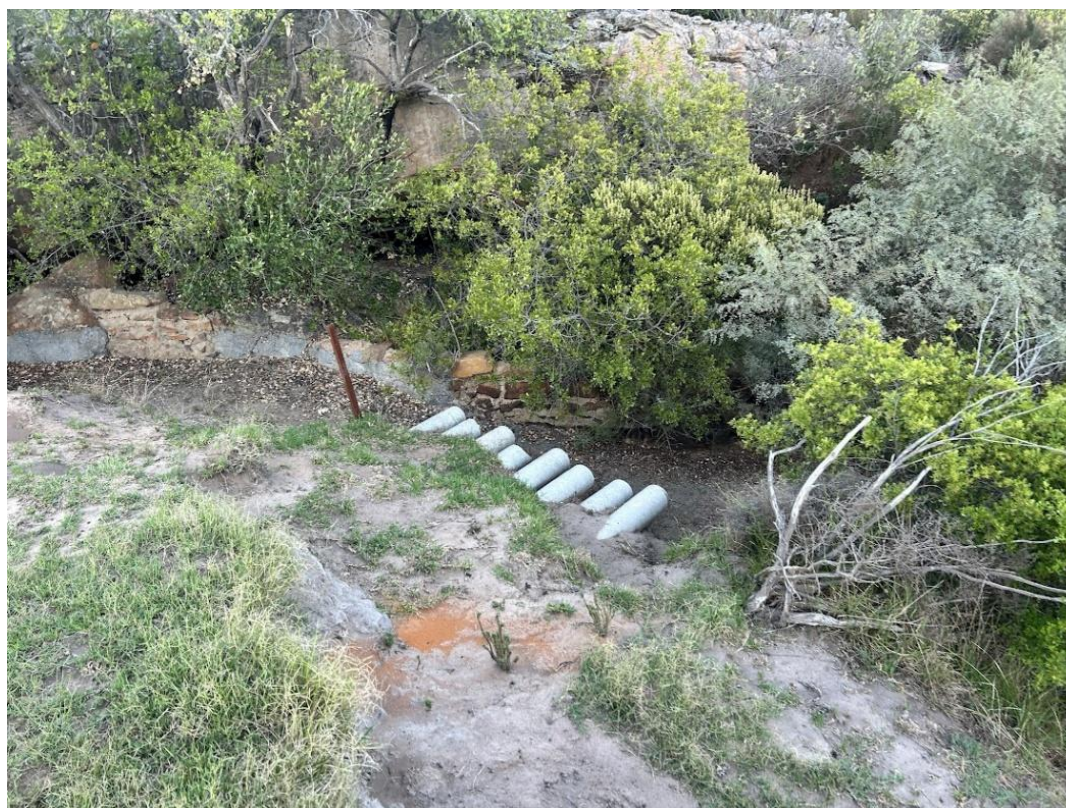
**Photograph 2.14**  
**Pipe outlets from Dam 4 into the concrete spillway**

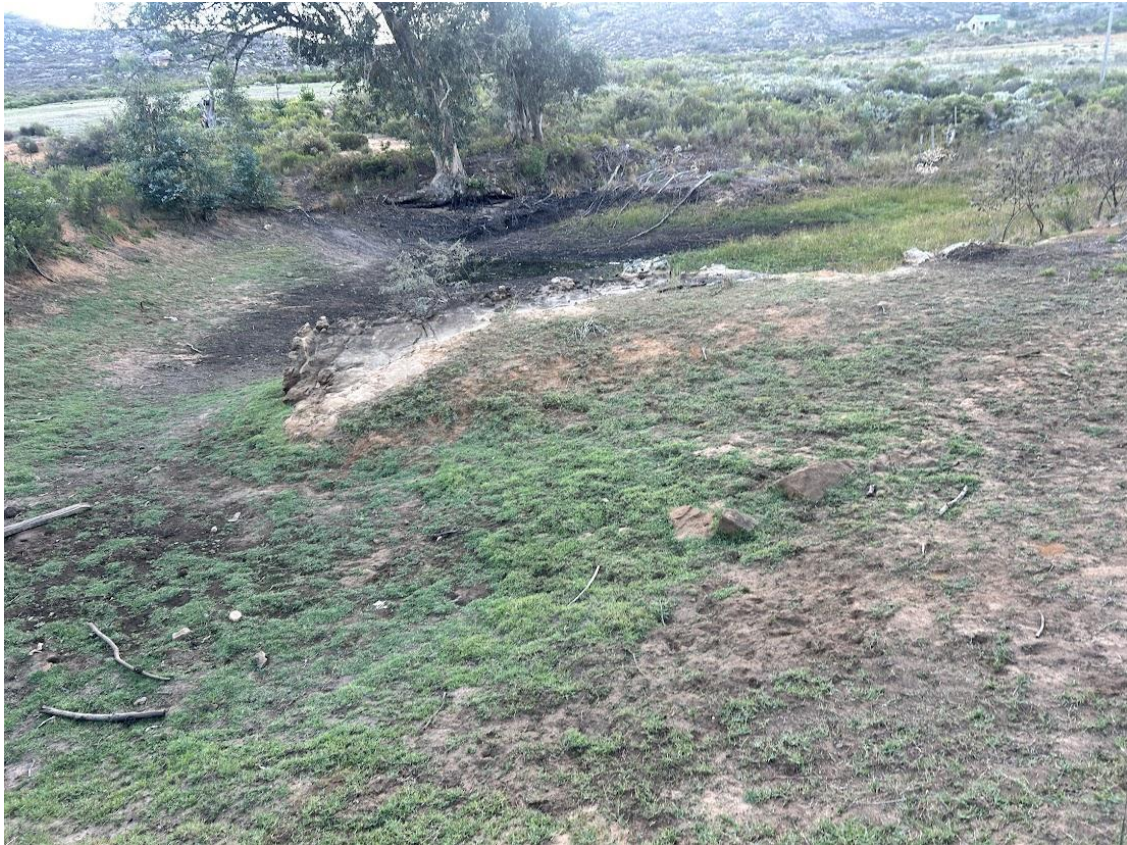
**Photograph 2.15**  
**Standing water in Dam 4 (April 2026)**

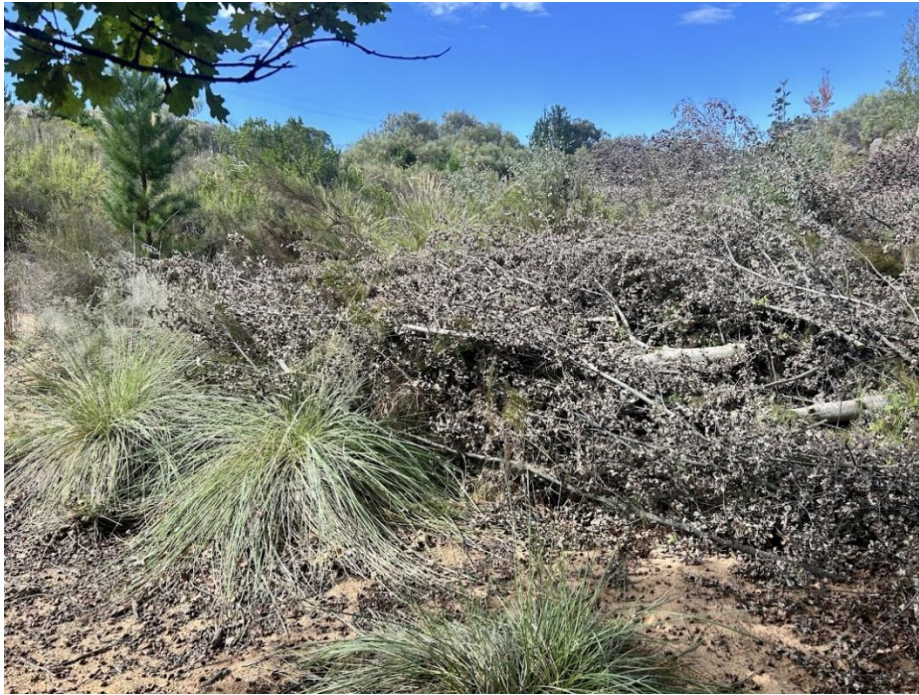
The watercourse in this area is channelised but less incised than in the reaches between Dams 3 and 4. Areas outside of the channel are dominated by *Pteridium aquilinum* but the valley bottom wetland itself is morphologically less impacted than in the upstream reaches, and includes relatively natural wetland habitat towards Dam 5, although the weir / dam wall at Dam 5 is likely to have played a part in reducing upstream channel incision at least in the reaches immediately upstream of the dam wall, which effectively flattens out the upstream channel gradient.

This reach of the watercourse has been assessed as PES Category C/D, taking into account existing indigenous vegetation, albeit with some (cleared) alien vegetation (see Photograph 2.16) and with the understanding that hydrology has been significantly impacted by upstream impoundment as well as by alien invasion.

**Photograph 2.16**  
**Watercourse between Dam 4 and Dam 5 (April 2026)**

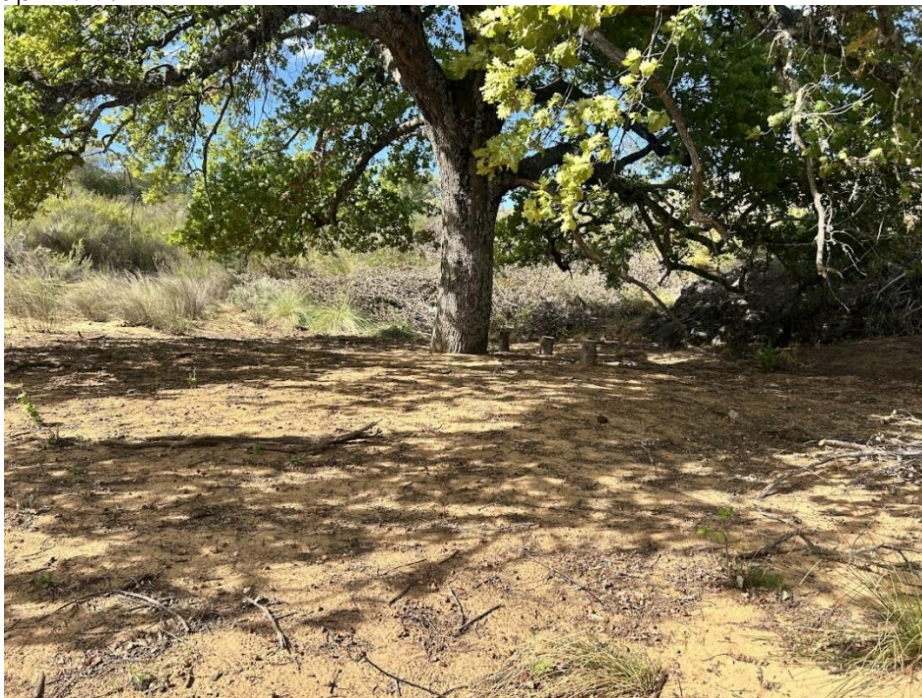
**Photograph 2.17**  
**Accumulated sediment in Dam 5 (April 2026)**

This dam/ impoundment was created by a concrete weir and was completely infilled with sediment at the time of the April 2016 site visit, suggesting significant or ongoing erosion of upstream areas between Dams 4 and 5 – this would probably largely be due to agricultural activities in this area, but could also reflect the more recent impacts of alien plant clearing in the upstream reaches, exacerbating sediment accumulation. , The impoundment is illustrated in Photograph 2.17.

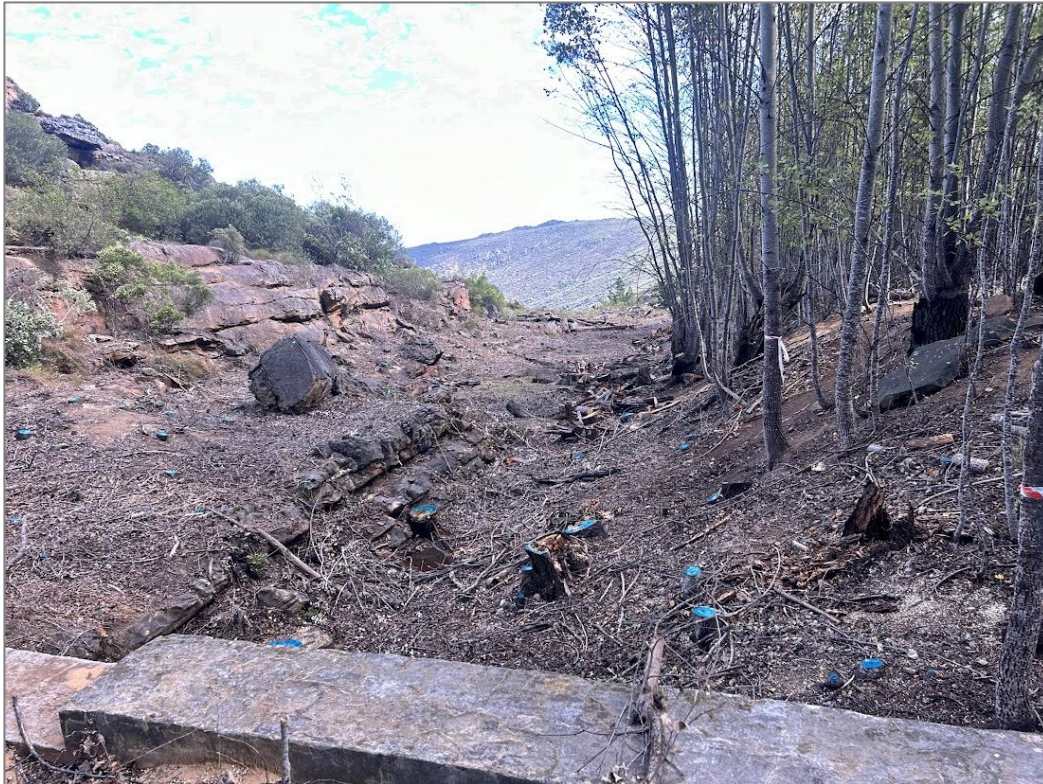
**Photograph 2.18**  
**Foothill stream downstream of Dam 5 (April 2026) – weir shown in foreground.**

This reach of the watercourse has been assessed as PES Category C, using a modified version of the Habitat Integrity rating of DWAF (1999) (in Southern Waters 2001) with the main impacts being invasion by alien vegetation (and its impacts on hydroperiod), upstream impoundment (and its impacts on hydrology and hydroperiod) and loss of indigenous vegetation.
